GLOBAL SAFETY FIELD INVESTIGATIONS  
DCS4924  
URGENT - DISTRIBUTE IMMEDIATELY

Subject: N182188440 - Customer Satisfaction Program  
Braze Incomplete Missing on Harness Bulkhead Support Bracket to  
Fuel Rail

# Customer Satisfaction Program

## N182188440 Braze Incomplete Missing on Harness Bulkhead Support Bracket to Fuel Rail

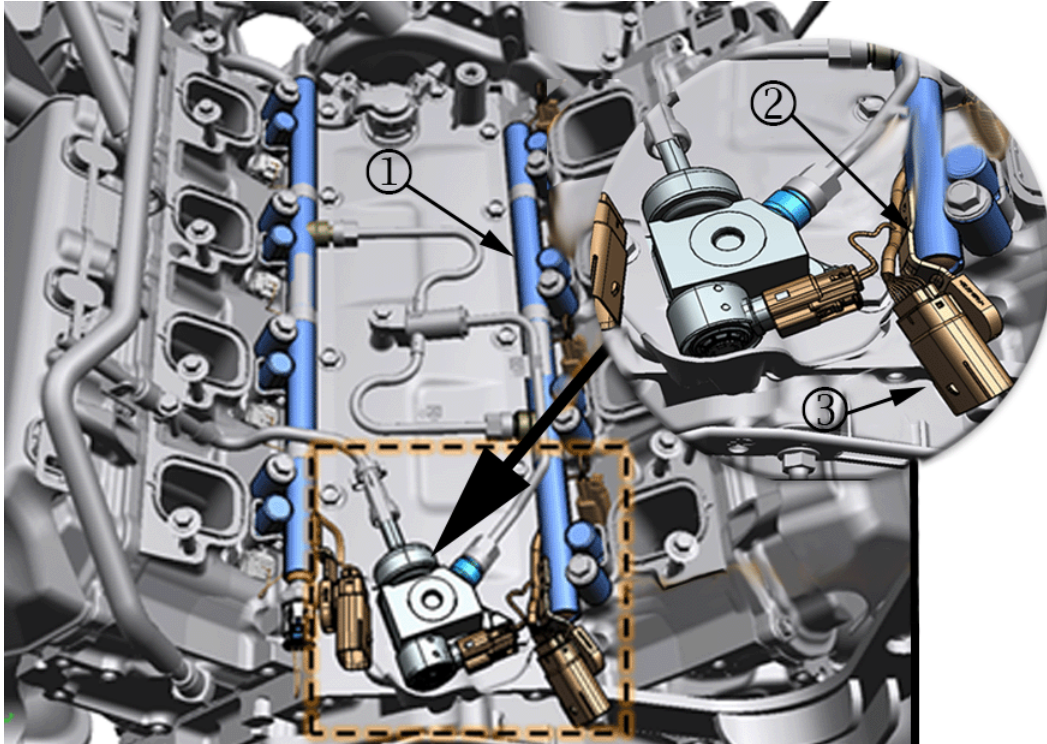
5182948

Illustration is shown with intake removed and is for perspective purposes only. Passenger Side Fuel Rail (1), Braze location (2), Right Bulkhead Harness Connector (3).

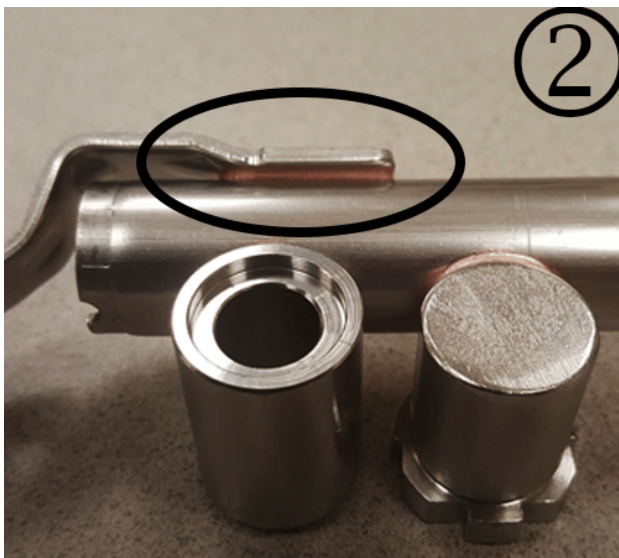
5172025

2. Inspect the bracket at the rear of the bank 2 (passenger's side) fuel rail to see if the braze was completed on the bracket.

- If the braze was completed (as shown in callout 2) no further action is required. Proceed to step 3.
