# Special Coverage Adjustment

## N182188250 Loss of Continuity within Accelerator Pedal Position Sensor Circuit

**Release Date:** August 2019

**Revision:** 01

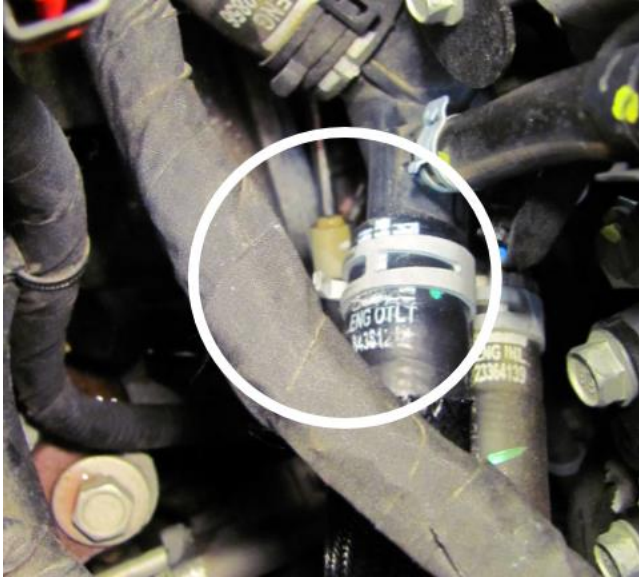
5309871

2. On Malibu (LFV engine) applications **only**, inspect the engine wire harness adjacent to the heater inlet hose for contact with the heater inlet hose clamp on the engine outlet portion of the hose as shown.

3. If contact is observed between the heater hose clamp and the engine wire harness, attempt to rotate the heater hose clamp tabs away from the engine harness, ensuring the clamp stays within the alignment guide markings.

- If the heater inlet hose clamp is **not** glued to the heater inlet hose, rotate the heater inlet hose clamp so the tabs are facing away from the engine wire harness. Ensure the clamp stays within the alignment guide markings. There should be at least  $\frac{3}{4}$  inch (19mm) of clearance between the heater hose clamp tabs and the engine wire harness.

- If the heater hose clamp **is** glued to the heater hose, replace the heater inlet hose and both heater hose clamps, being sure to clock the heater inlet hose clamps so the tabs are facing away from any adjacent engine wire harnesses. Ensure the clamp stays within the alignment guide markings. Refer to *Heater Inlet Hose Replacement (LFV)* in SI.

- If any damage is observed to the engine harness, repair the harness and the affected circuits. Refer to *Wire to Wire Repair* in SI. Rewrap the harness in the affected area with PET tape in addition to clocking the hose clamp away from the harness to ensure another rub-through event is no longer possible.
