Subject: 18226 - Special Coverage  
Overheating of Fuel Relay or Motor Terminal

Models: 2008-2011 Buick Lucerne  
2009-2011 Cadillac DTS

# Special Coverage Adjustment

## 18226 Overheating of Fuel Relay or Motor Terminal

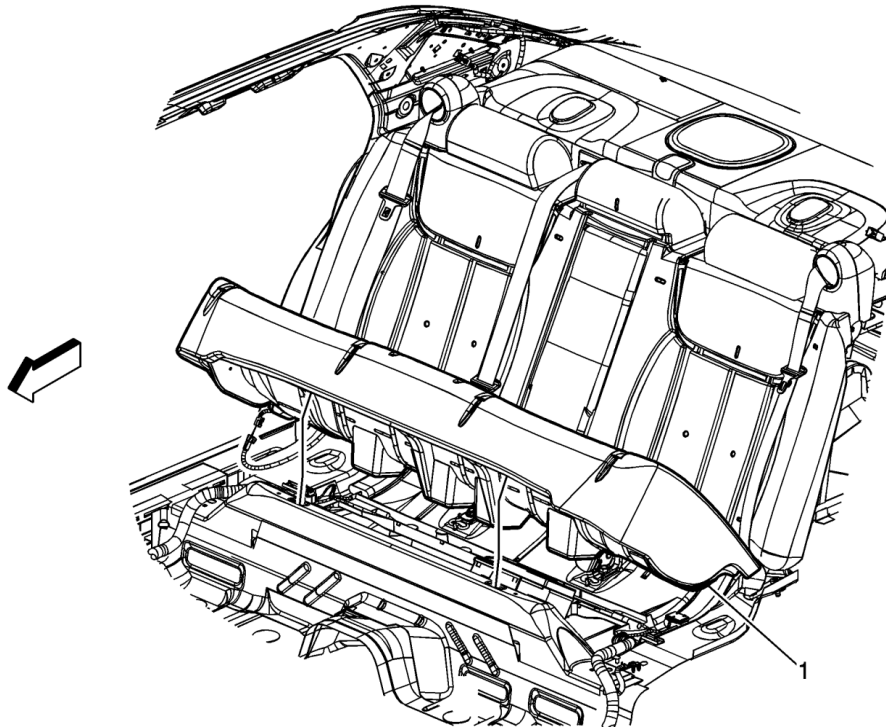
1572099

1. Remove the rear seat bottom cushion (1).
2. Disconnect the negative battery cable.

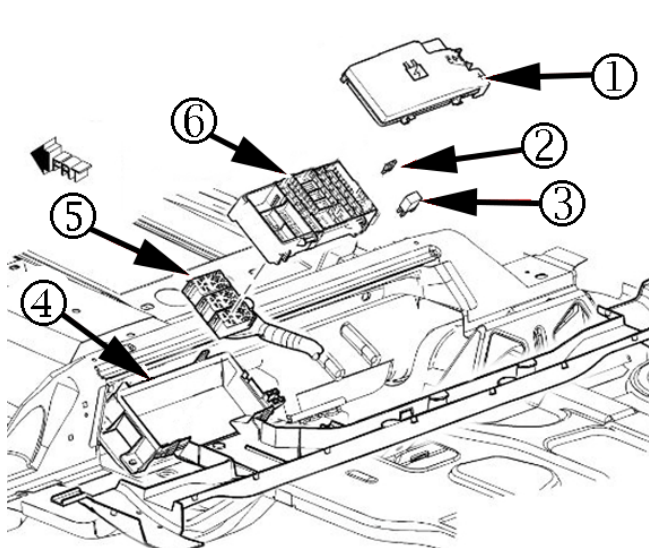
5118028

3. Remove the Rear Electrical Center (REC) cover (1).
4. Inspect the cover for signs of contact with the fuel pump relay.
5. Remove and inspect the fuel pump relay (3) for any signs of contact, damage and/or burn marks.
6. Remove and inspect the fuel pump fuse (2) for any signs of damage and/or burn marks.
7. Separate the upper REC (6) from the lower housing (4) by pressing the 4 locking tabs.
8. Inspect the REC for the following concerns:

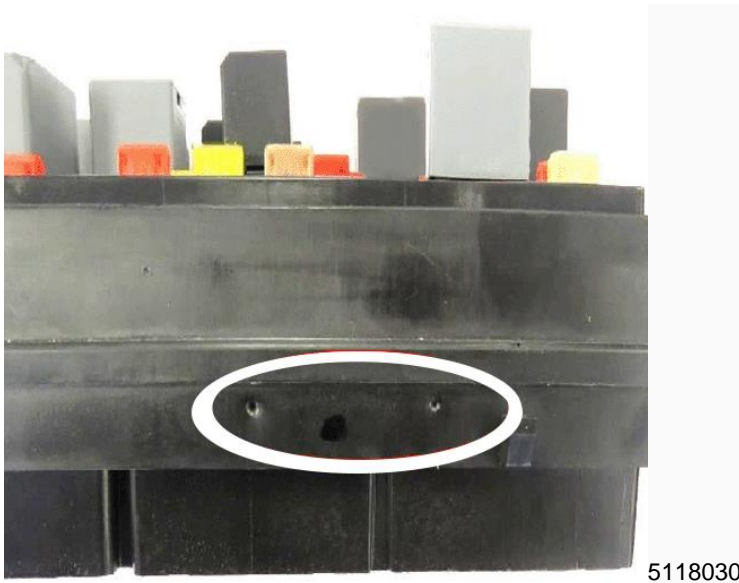
- Contact marks from the seat brackets. (Lucerne Only)

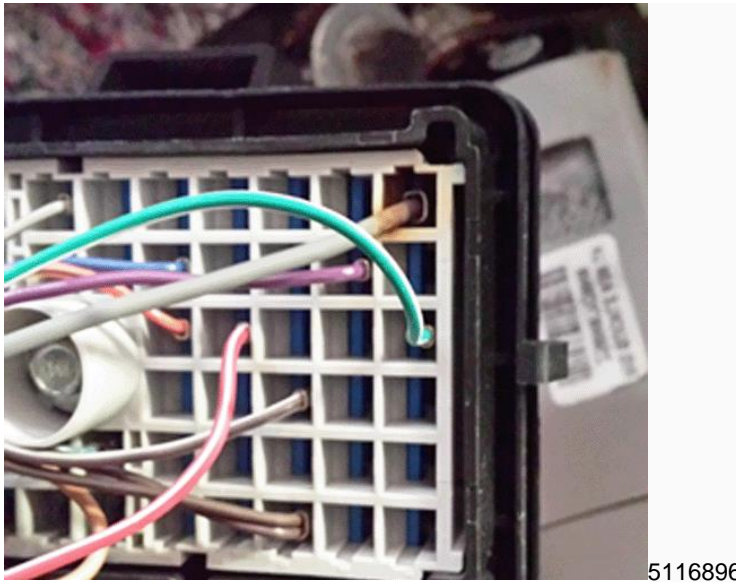
5116896

- Burnt wires or terminals at the F1 cavity.

- Replace the REC.
- Repair the wire terminal at the F1 cavity.
- If required, replace the X1 connector.
- Trim seat brackets. (Lucerne Only)
- Reposition REC. (DTS Only)

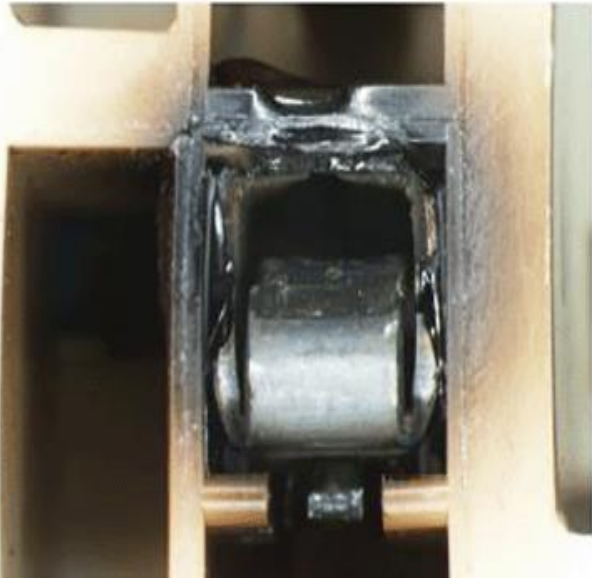
4871417

9. Remove the X1 connector from the REC.

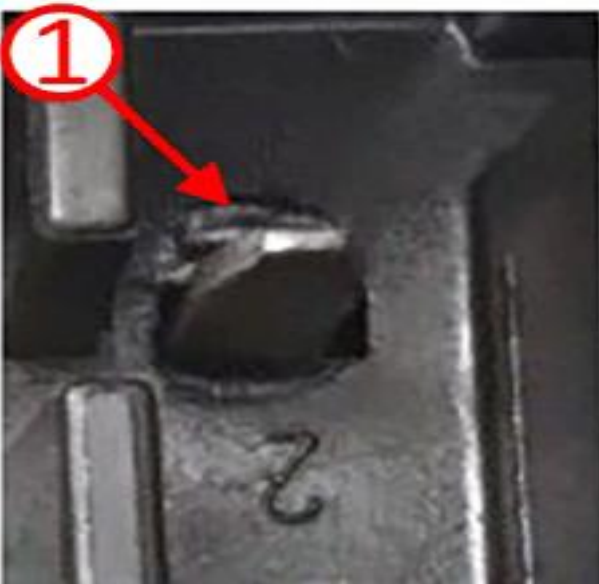
4871373

10. Inspect the connector for any damaged or burnt terminals.

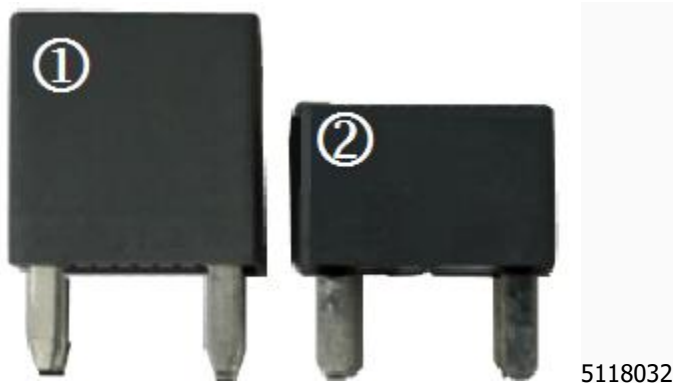
11. Inspect for any signs of warping or disfigurement caused by heat to the junction block (1).
- If no damage is found, **Do Not** replace the fuse block and refer to SI for further diagnostics.
- If damage was found, proceed with repair.

- Remove FPR relay (1) and discard.
- Install a low profile fuel pump relay (2).
- Trim seat brackets. (Lucerne Only)
- Reposition REC. (DTS Only)
