GLOBAL SAFETY FIELD INVESTIGATIONS
DCS4918
URGENT - DISTRIBUTE IMMEDIATELY

Subject: N182193520 - Service Update
Valve Body Solenoid Connection Not Seated

Models: 2019 Cadillac CTS
2018-2019 Chevrolet Camaro
2018-2019 Chevrolet Colorado
2019 Chevrolet Corvette
2018-2019 Chevrolet Express
2019 Chevrolet Silverado 1500 (New Model)
2019 GMC Canyon
2019 GMC Sierra 1500 (New Model)
Equipped w/8L45 or 8L90 (M5N/M5T/M5U/MQE) Auto Transmissions

N182193520 Valve Body Solenoid Connection Not Seated

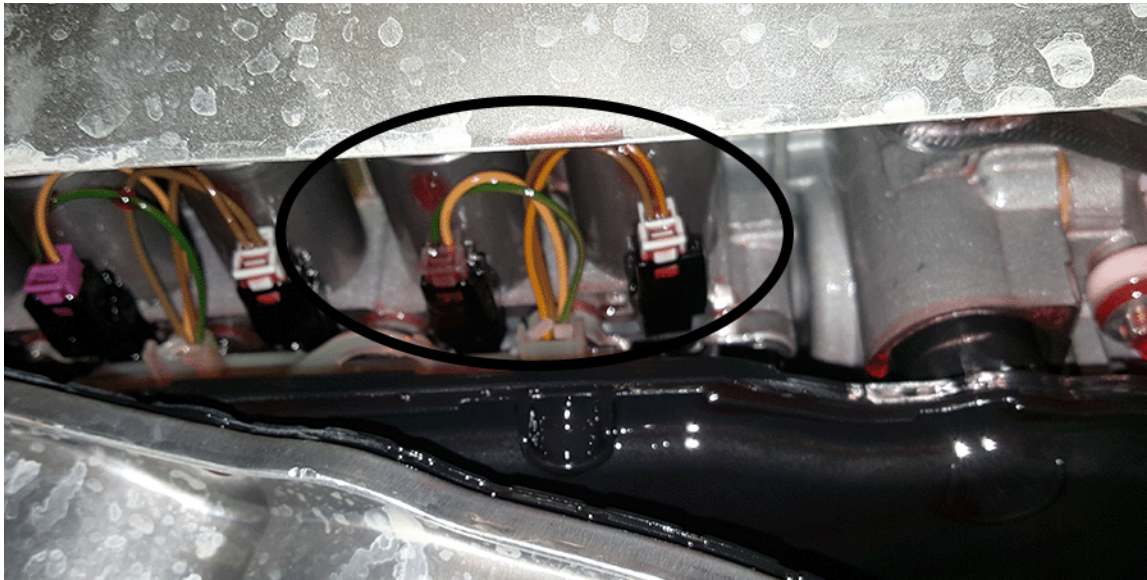
5180796

Condition	On a small number of the vehicles identified above, the electrical connector to the transmission valve body solenoids may not be fully seated. DTC P2718 or P2720 may set resulting in the Check Engine indicator illuminating, and the transmission reverting to a "limp home" mode providing limited forward gear selection.
Correction	Dealers are to access the transmission valve body solenoids and fully seat the connectors.

2. Locate the two valve body solenoid connectors towards the front of the vehicle as shown above. Press firmly on each connector to ensure it is fully seated in the valve body solenoid.
3. Reinstall the Automatic Transmission Fluid Pan. Refer to *Automatic Transmission Fluid, Fluid Pan and/or Filter Replacement*.
4. Fill the transmission with fluid. Refer to *Transmission Fluid Level and Condition Check* in SI.
