Date: December 21, 2018

Subject: N182201850 - Service Update
Cluster Display Reset

Models: 2019 Chevrolet Silverado 1500 (New Model)
2019 GMC Sierra 1500 (New Model)

N182201850 Cluster Display Reset

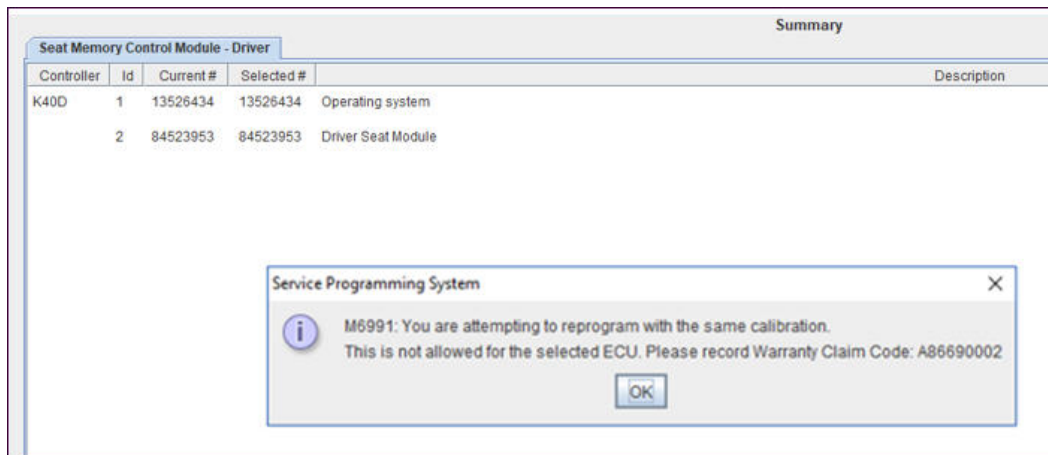
5164840

Note: If the Same Calibration/Software Warning is noted on the SPS Summary screen, record the warranty claim code (WCC) and select OK and follow screen instructions. The WCC is located in the Service Programming System dialogue box of the SPS Summary screen. No further action is required. Refer to the Warranty section of the bulletin.
