# GLOBAL SAFETY FIELD INVESTIGATIONS DCS4907 URGENT - DISTRIBUTE IMMEDIATELY

Subject: 18355 - Service Update

Repaint Lower Rocker (Customer Approval Required)

Models: 2019 Chevrolet Camaro equipped with A1Z and ZL1 (Extreme Track

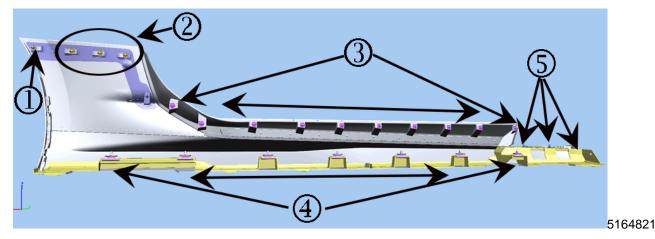
Location (Call Outs Above)	Part Number	Quantity (Total-both sides)
1	11547211	2
2	11546635	6
3	19352782	20
4	11611435	14
5	11612122	6
