GLOBAL SAFETY FIELD INVESTIGATIONS
DCS4914
URGENT - DISTRIBUTE IMMEDIATELY

Subject: 18207-02 - Customer Satisfaction Program
Loss of Power Steering Assist ** REVISED PARTS SECTION **

Models: 2013-2017 Cadillac ATS
2014-2017 Cadillac CTS
2016-2017 Chevrolet Camaro

Reference Number: N182161890

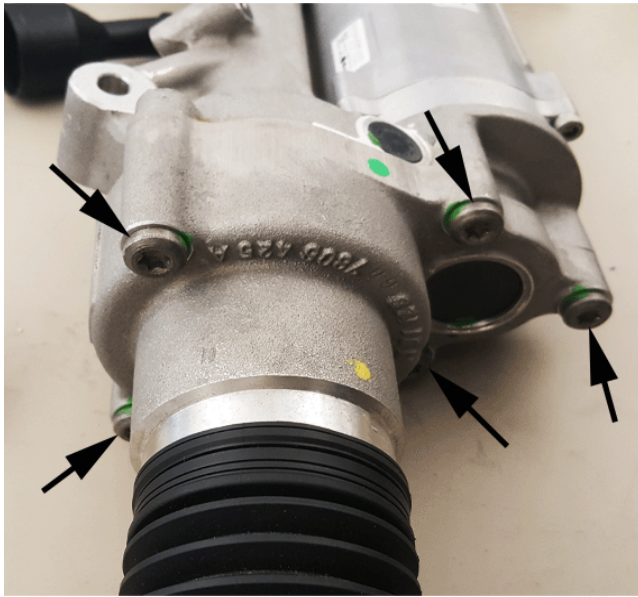
4646523

3. Inspect to see if all 5 electric belt drive rack and pinion steering gear bolts are present.
 - If all of the electric belt drive rack and pinion steering gear bolts are present, proceed to the next step.
 - If any of the electric belt drive rack and pinion steering gear bolts are missing, document on the repair order how many bolts were broken and replace the electric belt drive rack and pinion steering gear. Refer to *Electric Belt Drive Rack and Pinion Steering Gear Replacement (Non V-Series With AWD)* in SI.

4. Remove the drivetrain and front suspension frame. Refer to *Drivetrain and Front Suspension Frame Removal and Installation (Non V-Series)* or *Drivetrain and Front Suspension Frame Removal and Installation* in SI.
5. Perform the wax installation procedure by leaving the electric belt drive rack and pinion steering gear attached to the drivetrain and front suspension frame. Do NOT remove the steering gear bolts securing the steering gear to the drivetrain and front suspension frame. Refer to *Wax Installation Procedure* in this bulletin.
6. Install the drivetrain and front suspension frame. Refer to *Drivetrain and Front Suspension Frame Removal and Installation (Non V-Series)* or *Drivetrain and Front Suspension Frame Removal and Installation* in SI.

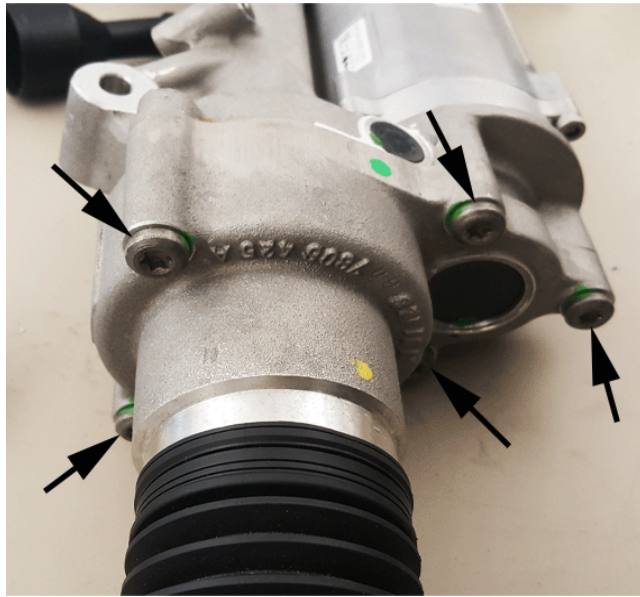
4646523

3. Inspect to see if all 5 electric belt drive rack and pinion steering gear bolts are present.
 - If all of the electric belt drive rack and pinion steering gear bolts are present, proceed to the next step.

- If any of the electric belt drive rack and pinion steering gear bolts are missing, document on the repair order how many bolts were broken and replace the electric belt drive rack and pinion steering gear. Refer to *Electric Belt Drive Rack and Pinion Steering Gear Replacement (Non V-Series With RWD, Without KC4)*, *Electric Belt Drive Rack and Pinion Steering Gear Replacement (Non V-Series With RWD, With KC4)*, *Electric Belt Drive Rack and Pinion Steering Gear Replacement (Non V-Series With RWD)*, *Electric Belt Drive Rack and Pinion Steering Gear Replacement (V-Series)*, *Electric Belt Drive Rack and Pinion Steering Gear Replacement (LGX, LTG)*, or *Electric Belt Drive Rack and Pinion Steering Gear Replacement (LT1)* in SI.

4. Perform the wax installation by applying wax to the electric belt drive rack and pinion steering gear to all areas accessible from underneath the vehicle. Refer to *Wax Installation Procedure* in this bulletin.

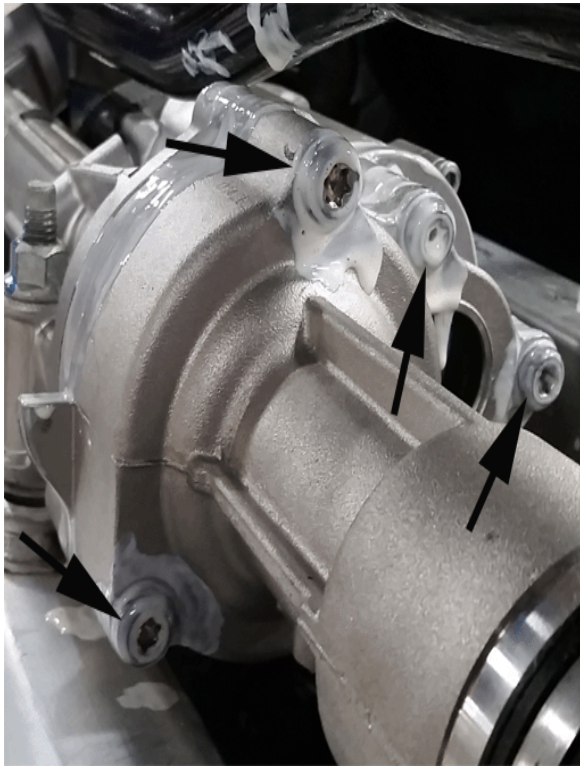
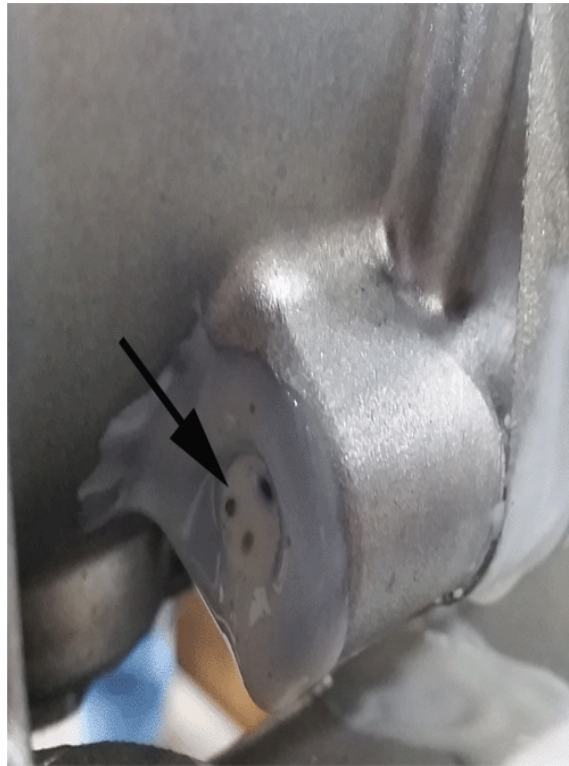
4646560

Note: One of the electric belt drive rack and pinion steering gear bolts is not pictured.

6. Apply wax around the electric belt drive rack and pinion steering gear bolts and bolt holes as shown above.
