GLOBAL SAFETY FIELD INVESTIGATIONS
DCS4893
URGENT - DISTRIBUTE IMMEDIATELY

Date: November 1, 2018
Subject: 18347 - Service Update
Incorrect OnStar Button Icon
Models: 2019 Chevrolet Camaro
To: All General Motors Dealers

18347 Incorrect OnStar Button Icon

Reference Number: N182196010

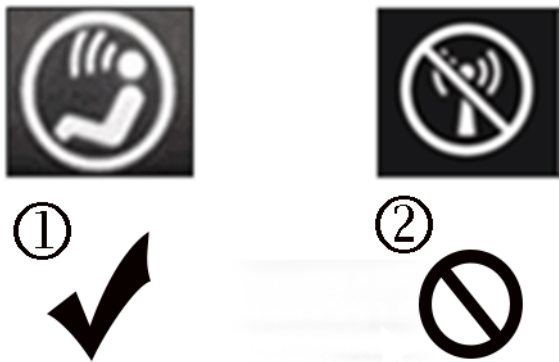
5159513

Condition	On certain 2019MY Chevrolet Camaro vehicles, the overhead console OnStar push-to-talk button is printed with the incorrect icon.
Correction	Replace the overhead console OnStar switch.

1. Replace the OnStar roof console switch. Picture 1 shows the correct icon and picture 2 shows the incorrect icon.
2. Remove the roof console. Refer to *Roof Console Replacement* in SI.
