Service Update

18348 Shifter Stuck in Park with DTC P189D

Reference Number: N182193580 Release Date: November 2018

Models: 2019 Cadillac XT4

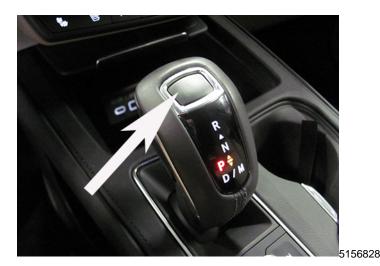
Note: During the cycling of the park button, there is the potential to induce faults when the button is cycled quickly that will generate other DTCs resulting in the "Service Shifter" warning. The technician should still complete the cycling and updating the ECM. DTCs will pass after the park button is pressed in a normal, non-repeated manner.

- Cycle the park button on the transmission electronic control 100 times, use the following pattern. Depress the button for one second and release for two seconds, repeat the one second depressed, two second released for one hundred cycles.
- Reprogram the engine control module (ECM). Refer to K20 Engine Control Module: Programming and Setup in SI.
- 3. Record SPS Warranty Claim Code on job card for warranty transaction submission.
