Technical Journal

Audio switches on steering wheel, no function

REF NO: TJ 32033.3.0	ISSUING DEPARTMENT: Technical Service	CAR MARKET: United States and Canada	
PARTNER: 3 US 7510 Volvo Car USA		ISSUE DATE: 2018-04-16	STATUS DATE: 2018-04-26
FUNC GROUP: 6414	FUNC DESC: Steering wheel, control buttons	Page 1 of 3

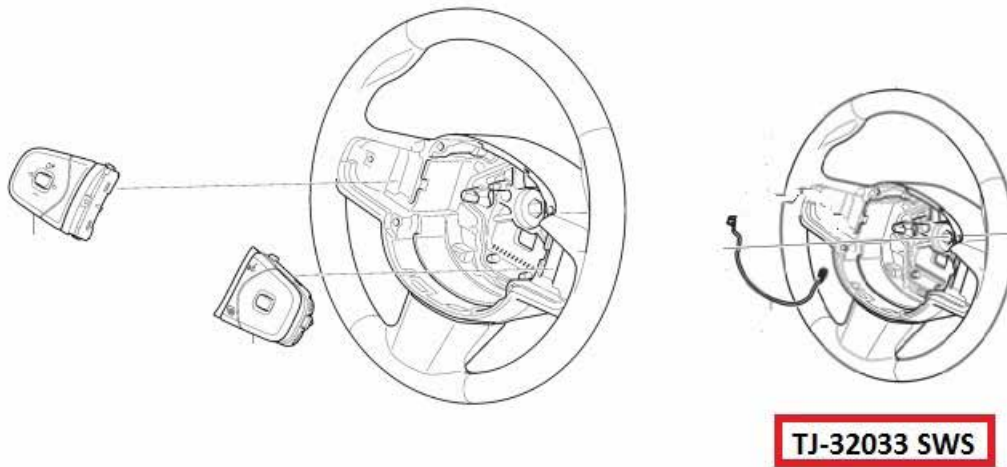
A connection issue in the steering wheel switches may give intermittent or permanent function loss on any of the audio switches.

If the customer complaint does not match symptom 1 or the car has been updated after week 19, 2017 then replace both steering wheel switches and the wires harness in between the switches, see attached picture TJ 32033 SWS.jpg
