Technical Journal

Click noise from rear body / suspension / shock absorber

REF NO: TJ 33962.3.0	ISSUING DEPARTMENT: Technical Service	CAR MARKET: United States and Canada		
3 US 7	PARTNER: '510 Volvo Car USA	ISSUE DATE: 2018-09-25	STATUS DATE: 2018-10-08	
FUNC GROUP: 7612	FUNC DESC: Shock absorber, rear	Page	1 of 3

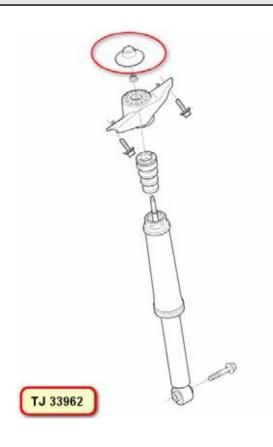
- wheel
- outer wheelhouse trim panel
- plastic cap from the shock absorber top mount (see picture 1)

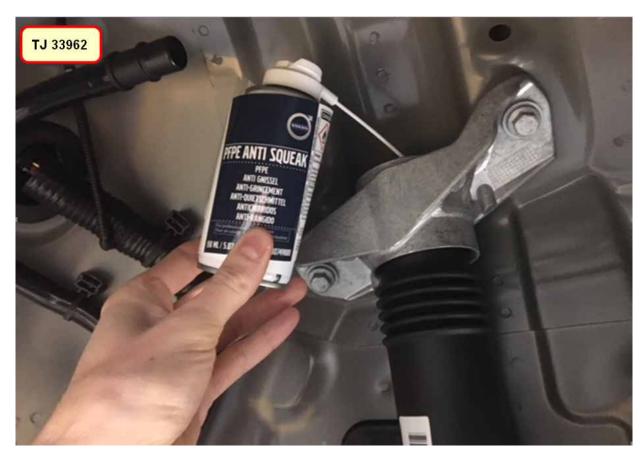
If there is a rattling / clicking / ticking noise while driving, and the noise is likely coming from the rear body or rear suspension, please follow the advice under Service.

Spray PFPE anti-squeak grease in the upper opening in the top mount (see picture 2) for about 5 - 10 seconds.

Note: Change direction of the spray nozzle while spraying so that the grease is distributed evenly, to make sure the grease is inserted all around between inside rubber and top mount metal cap.
