Technical Journal

Steering wheel off center

REF NO: TJ 33715.1.0	ISSUING DEPARTMENT: Technical Service	CAR MARKET: United States and Canada	
PARTNER: 3 US 7510 Volvo Car USA		ISSUE DATE: 2018-04-18	STATUS DATE: 2018-04-26
FUNC GROUP: 6410	FUNC DESC: Steering wheel, column lock, steering co	Page 1 of 3

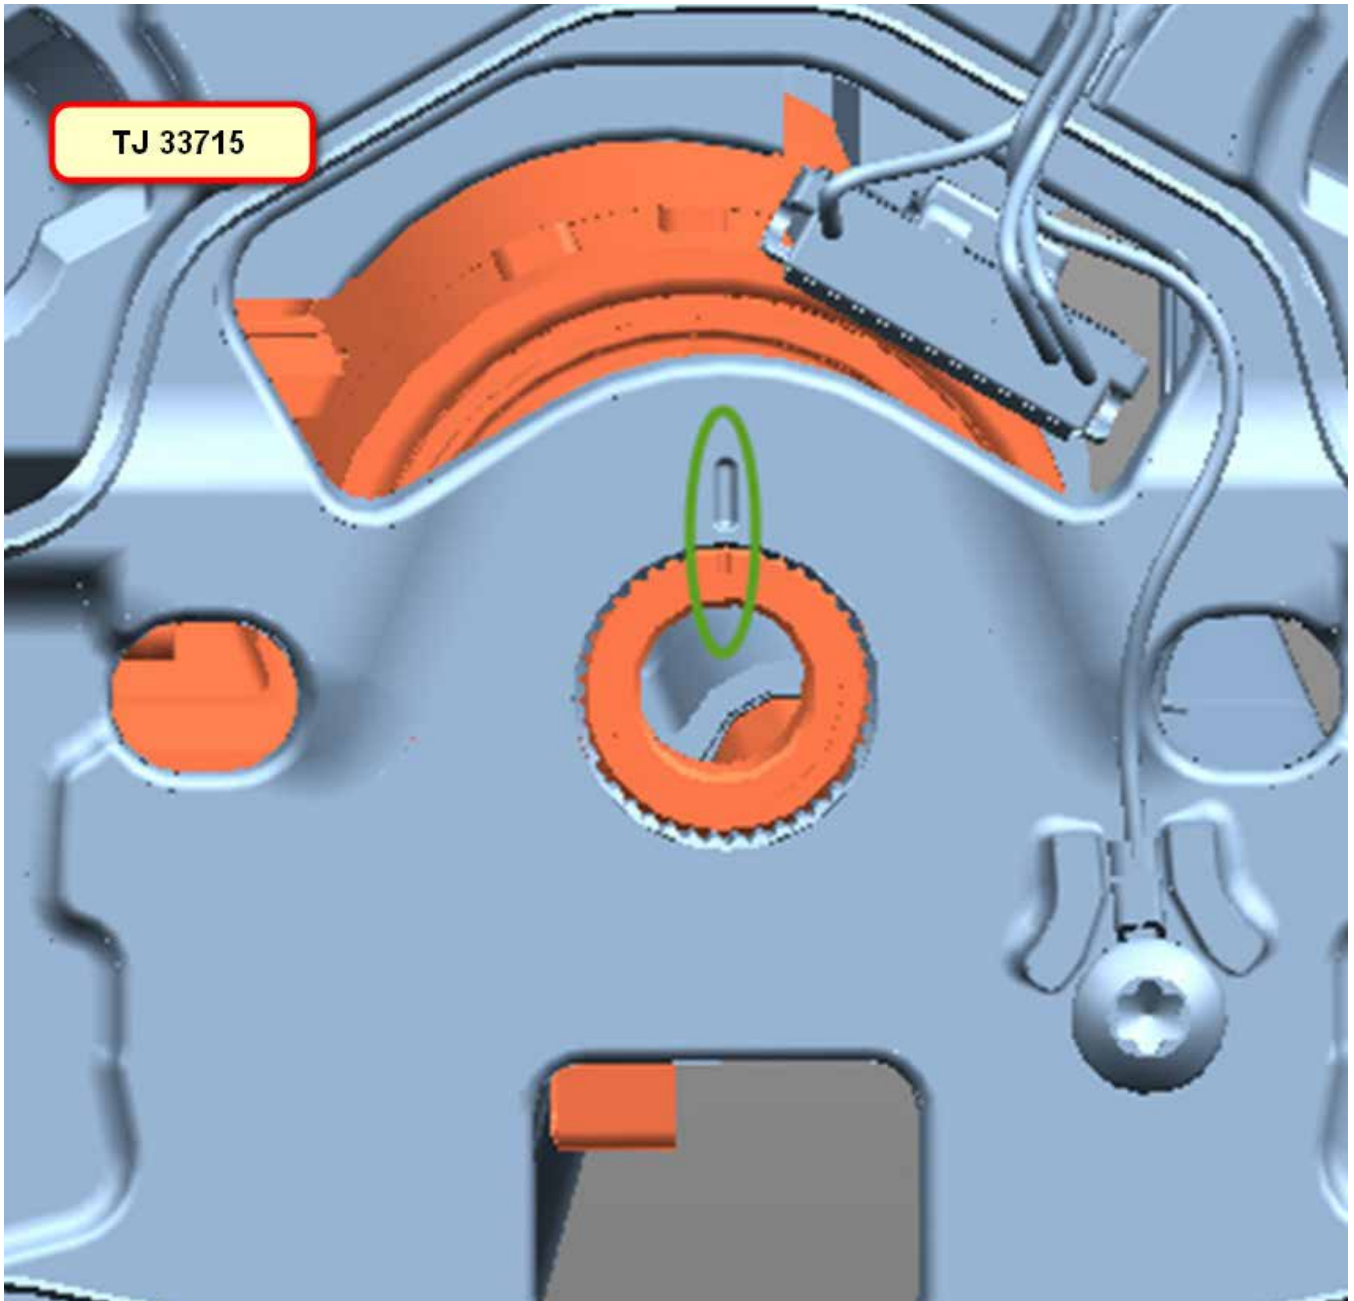
File Name	File Size
TJ 33715.jpg	0.1113 MB

If steering wheel is off center while driving straight forward, then follow Service below.

The steering wheel is always positioned correctly at the assembly line, but if the steering wheel is removed for various adjustments it may not be reinstalled correctly on the steering column.

1. Remove driver's airbag according to VIDA (VCC-ID: VCC-502656-1)
2. Remove the screw for the steering wheel according to VIDA (VCC-ID: VCC-502279-1)
3. Align the steering wheel to the steering column, follow the markings according to the picture TJ 33715.jpg
4. Reinstall all parts according to VIDA (torque screw 60 N)
5. Perform a wheel alignment on front wheels according to VIDA (VCC-ID: VCC-502859-1)
5. Verify repair
