TITLE: Left engine pad click sound

| REF NO: | ISSUING DEPARTMENT: | | ARKET: |
|---|---|---|---|
| TJ 33442.9.1 | Technical Service | | s and Canada |
| FUNC GROUP: 2180 | FUNC DESC: Engine mounting | Page | 1 of 7 |

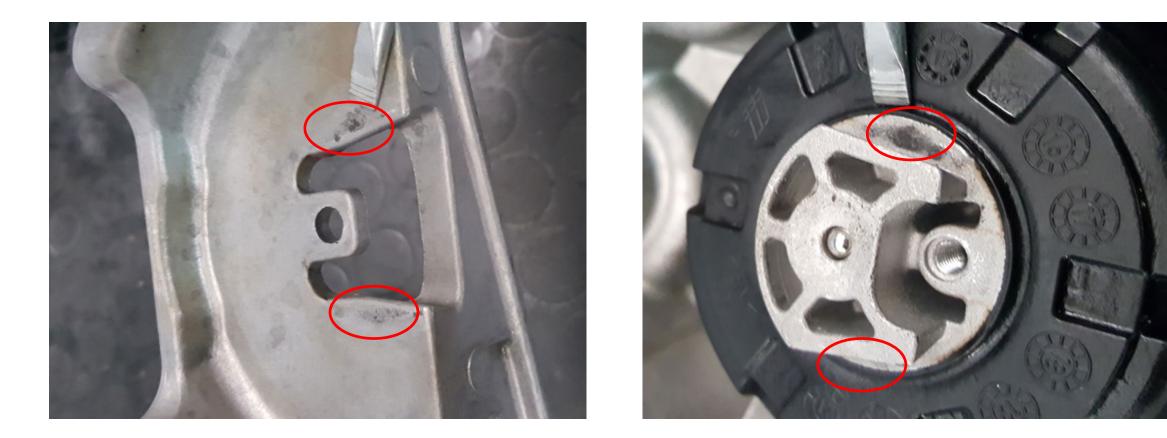
SPA – Left engine pad click sound

If the vehicle has a click sound from the left engine pad during driving, (a metallic click sound from A-pillar area)

Separate the engine pad and lubricate with graphite (see attachment), then follow instruction with new screw and washer. Torque 10 NM.

Put lubricating grease with graphite on red marked points as in pictures above.
