Technical Journal

Trunk lid difficult to open

REF NO: TJ 33432.2.0	ISSUING DEPARTMENT: Technical Service	CAR MARKET: United States and Canada	
PARTNER: 3 US 7510 Volvo Car USA		ISSUE DATE: 2018-01-22	STATUS DATE: 2018-02-05
FUNC GROUP: 8320	FUNC DESC: Boot lid, tailgate with hinge and suppor	Page 1 of 3

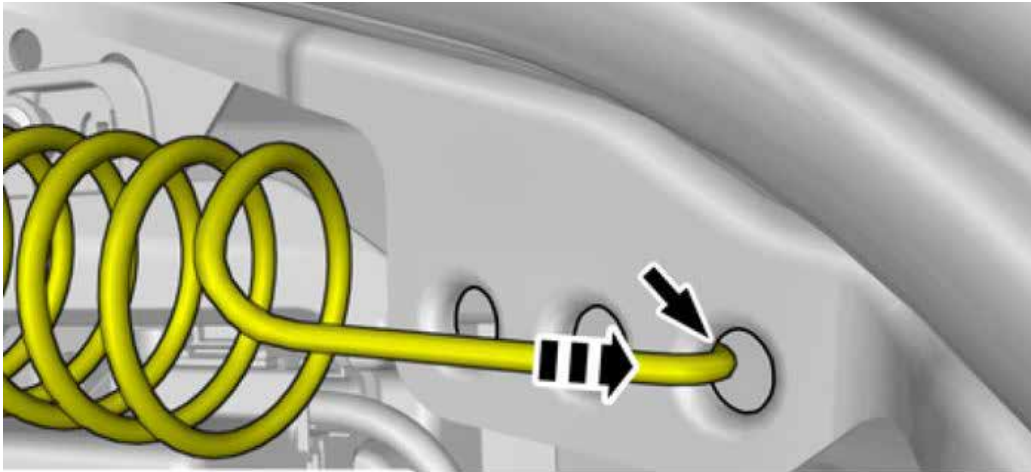
If the trunk lid is difficult to open, it may be due to the incorrect spring position. Follow advice under service.

Position A is vehicle with accessory spoiler on trunk lid.

Check the trunk lid spring, see attachment.

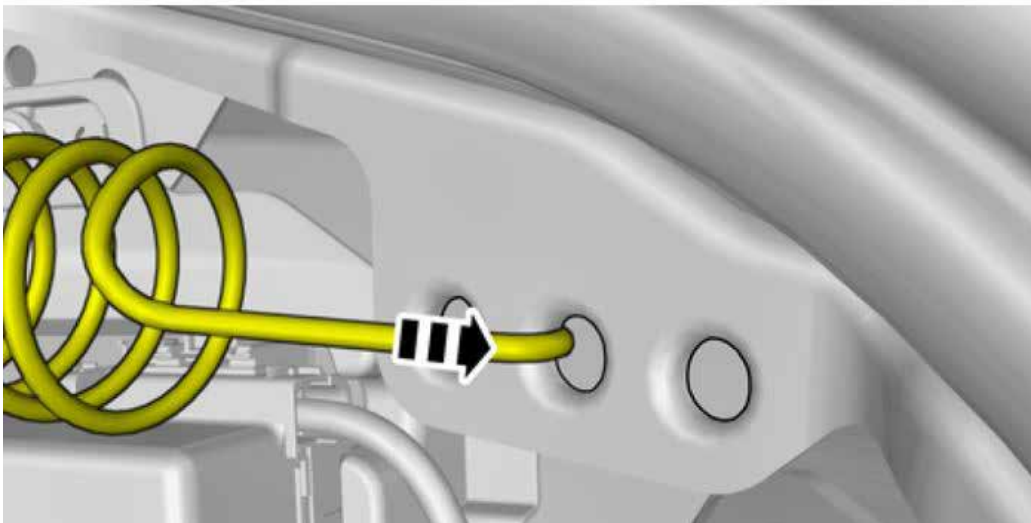
Position B is vehicle without accessory spoiler on trunk lid.
