Crackling sound from the B&W front door midrange speaker

REF NO: TJ 33419.1.0	ISSUING DEPARTMENT: Technical Service	CAR MARKET: United States and Canada	
PARTNER: 3 US 7510 Volvo Car USA		ISSUE DATE: 2018-02-09	STATUS DATE: 2018-02-19
FUNC GROUP: 3953	FUNC DESC: Loudspeaker; loudspeaker cables	Page 1 of 3

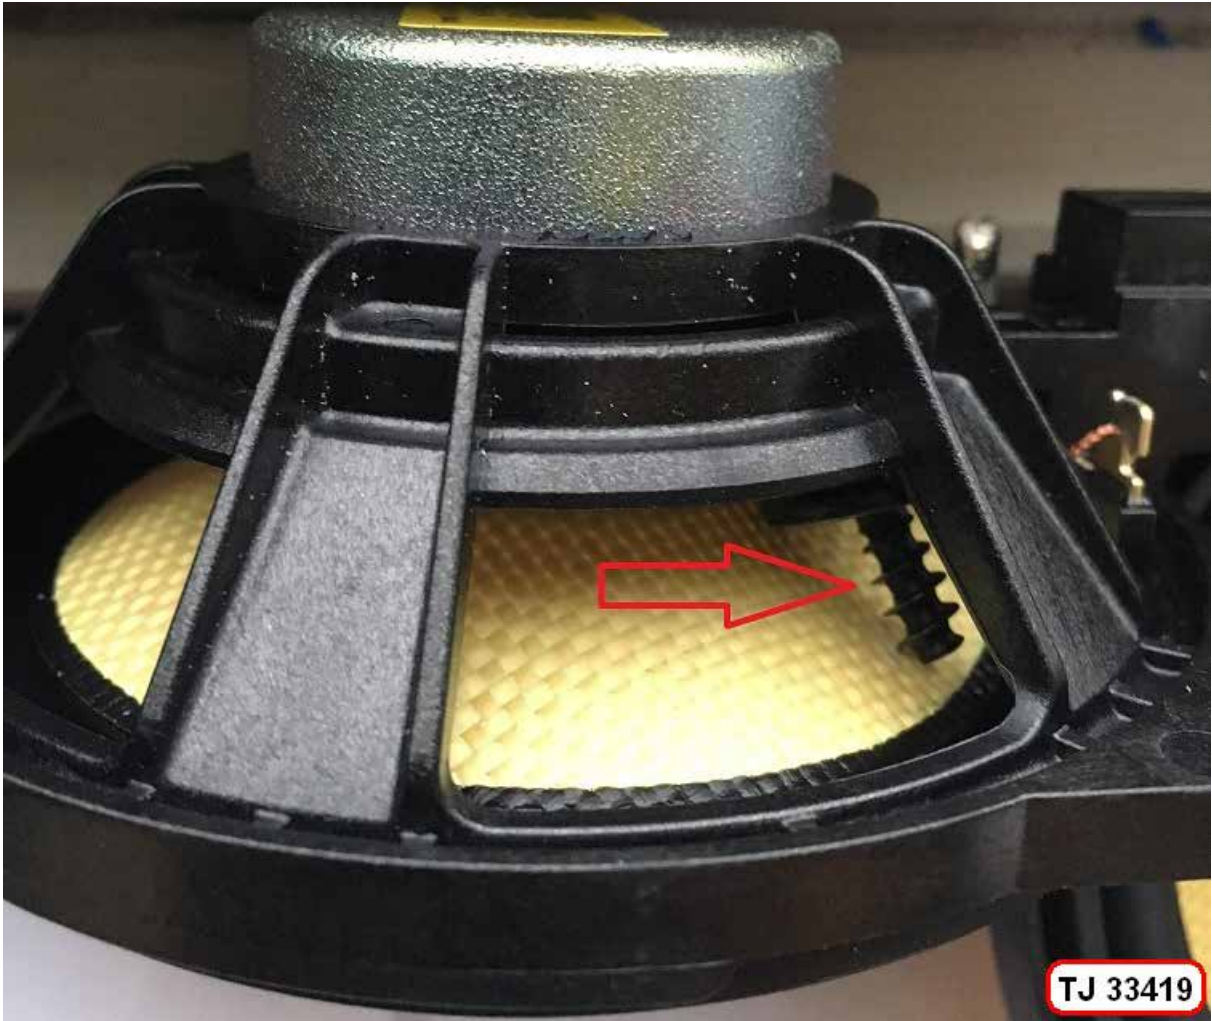
Vehicles with Bowers & Wilkins (B&W) Premium Sound may exhibit a crackling sound from the front door midrange speaker.

Check for a screw stuck between the membrane and spider-cage assembly. See attached picture, "TJ 33419 screw.jpg".

A magnetic sleeve was introduced into the supplier assembly process during 2018w05 to reduce the possibility for this issue.

The screw may be possible to remove with long nose pliers without damaging the membrane or spider surfaces. If the membrane or spider surfaces are damaged, please replace the loudspeaker.
