Technical Journal

Blown fuse, compressor - air suspension

REF NO: TJ 31423.14.0	ISSUING DEPARTMENT: Technical Service	CAR MARKET: United States and Canada	
PARTNER: 3 US 7510 Volvo Car USA		ISSUE DATE: 2019-04-01	STATUS DATE: 2019-04-11
FUNC GROUP: 7641	FUNC DESC: Level control, complete	Page 1 of 15

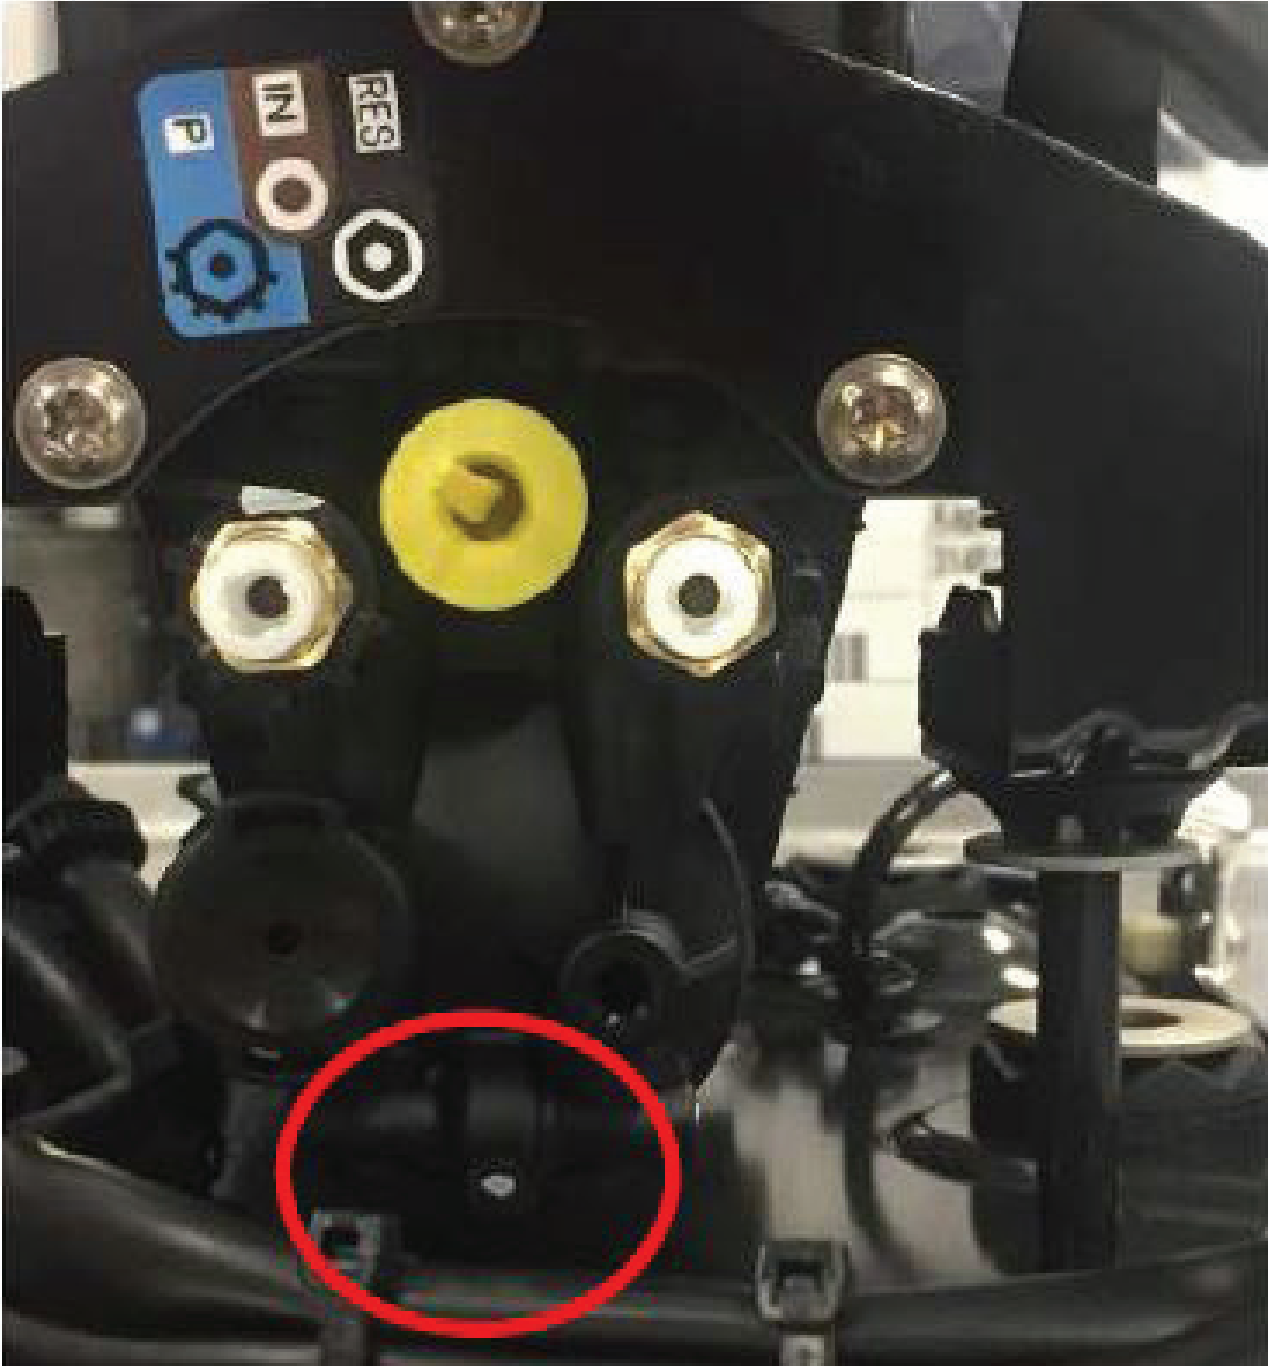
Improved compressors have been introduced in production (and spare parts) from March 2019, these are marked with a white dot, refer to picture [TJ 31423 - 1.jpg](#).
