To: All Subaru Retailers
From: Subaru of America, Inc. – Service
Date: July 2, 2018
Re: *Harman Gen 3 Audio and Navi Head Unit update - In-stock Vehicles*

SERVICE BULLETIN

NUMBER: 15-211-17R
DATE: 06/13/17
REVISED: 07/25/18

SUBJECT: Reprogramming File Availability for Additional Optimization of Harman Gen 3 Audio and Navigation Head Units

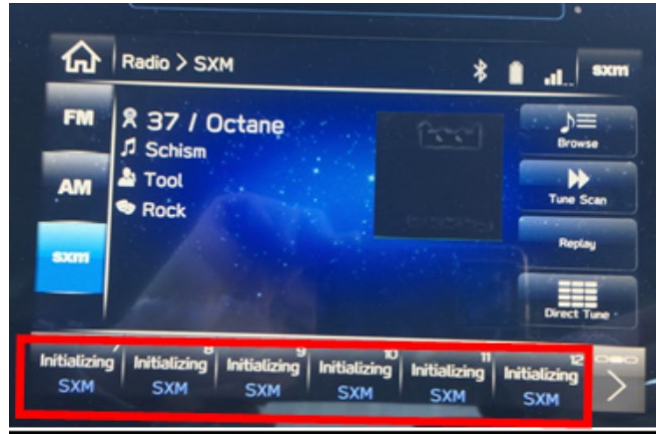
- On 2018MY Legacy / Outback models with Navigation (High) head units, the update corrects a condition where the head unit remains powered even after the ignition is OFF and the driver door is opened.
- Corrects for a condition where the SXM presets become lost and only “Initializing” appears as shown below.

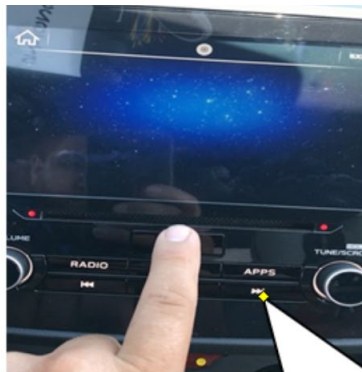
- Corrects for condition where only the star field background is displayed (without icons) after the HOME button is pressed.

Background shown, but no icons

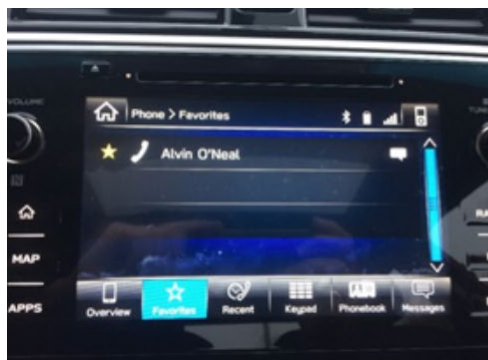
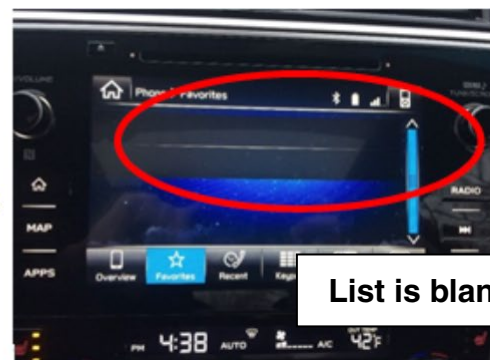
- Corrects for a “Pop” or “Crackling“ sound concern when listening to AM radio.
- Corrects for a concern of the head unit continually resetting itself.
- Corrects for a concern of after selecting a contact to be a “Favorite” and the “Favorite” list display is blank.

List is blank

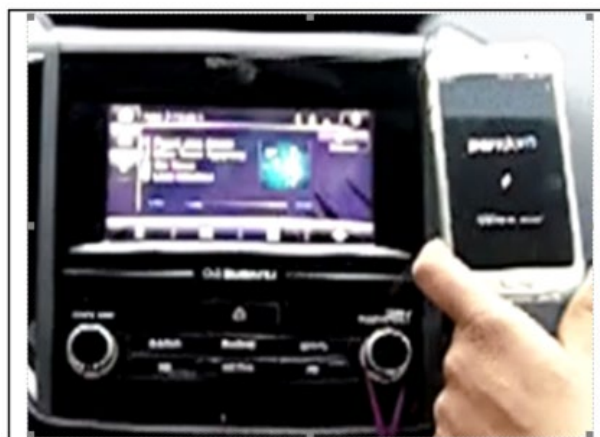
- 1- No streaming audio. When using the Pandora® app, there is no audio output.

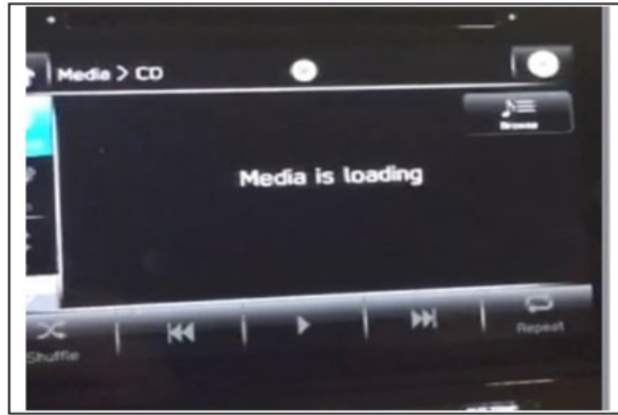
- 2- “Media is loading” is displayed on the screen but, the media never completes loading.

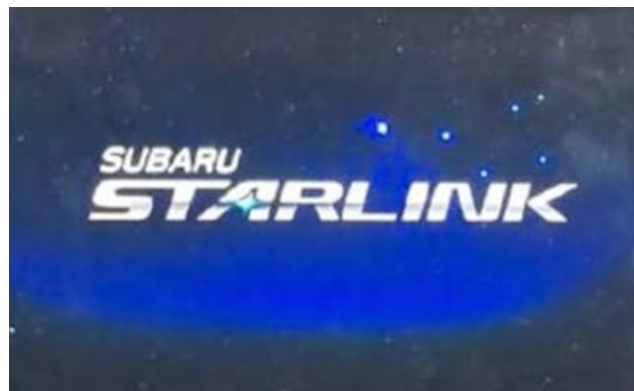
- 3- The screen freezes when the STARLINK screen is displayed.

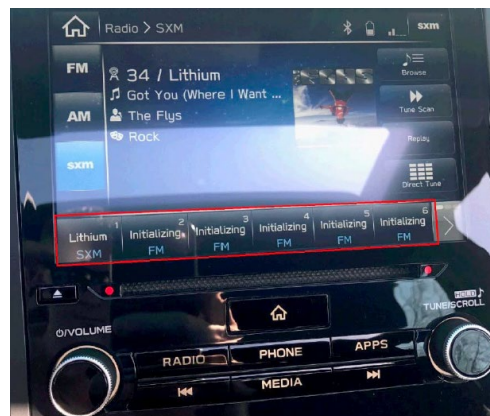
- 1- Radio station presets disappear (touch screen buttons return to “Initializing”).

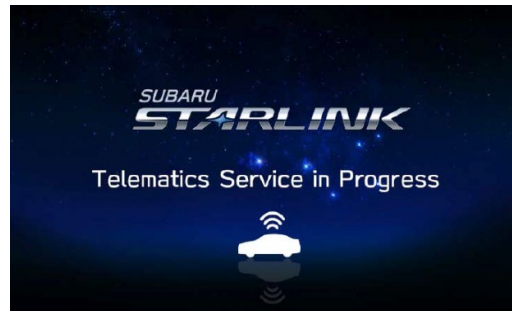
2- STARLINK “Telematics Service in Progress” screen freezes.

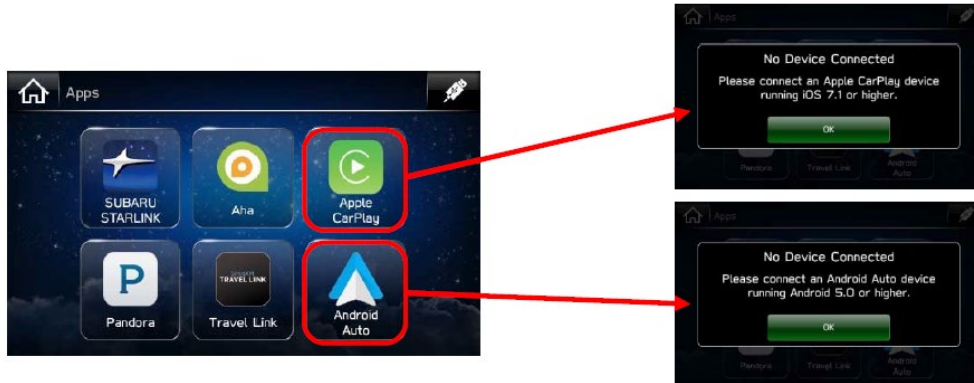
3- Apple Car Play / Android Auto function does not operate (“No Device Connected”).

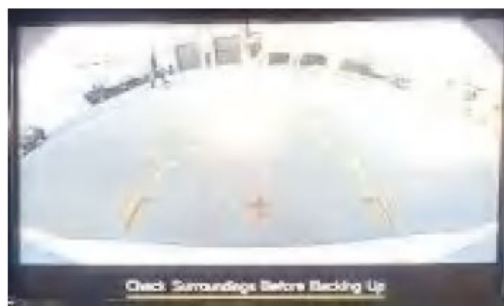
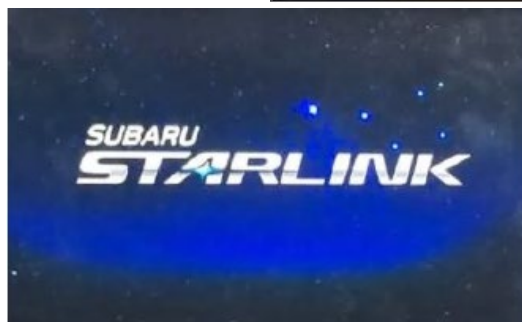
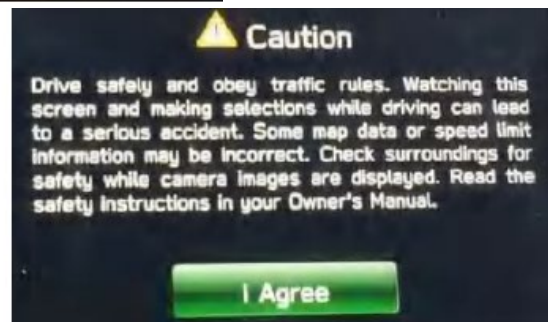
For reference, the previously released WTN-74R symptoms are also provided below. The main purpose of WTN-74R was to address display screen freeze-up during Back-Up Camera display (when the shifter is in “R”). In addition, the screen may also freeze when either the Subaru STARLINK or Disclaimer Caution / I Agree screen is displayed.

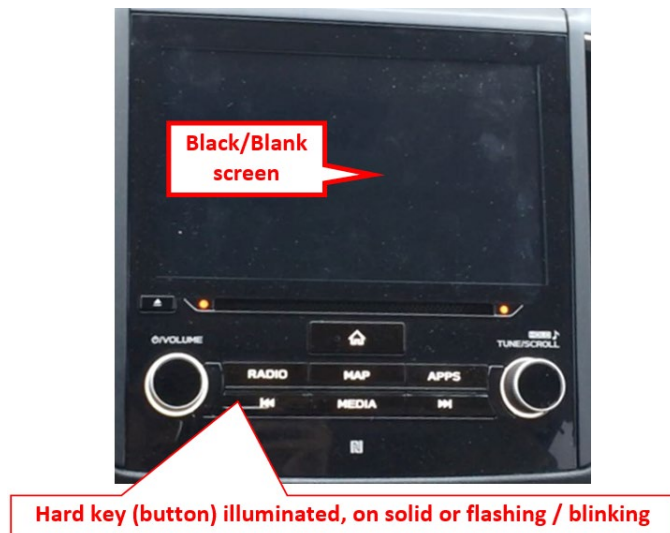
- 1) After switching the vehicle (ACC or IGN) on, the display screen goes black with no audio output and the hard key buttons are illuminated (on solid, or flashing / blinking).

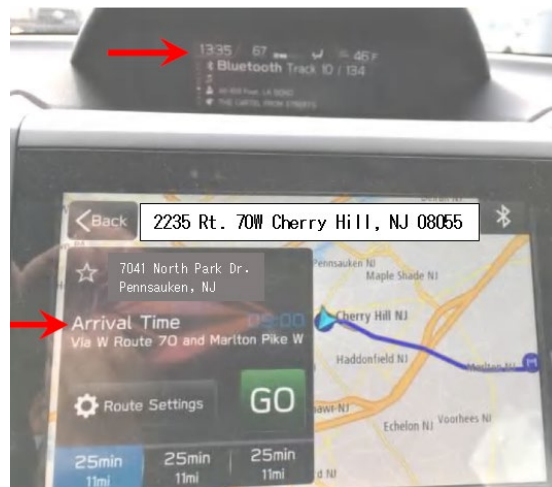
- 2) Time of day displayed in the MFD (Multi-Function Display) is incorrect and the arrival time displayed in Navigation units is also incorrect.

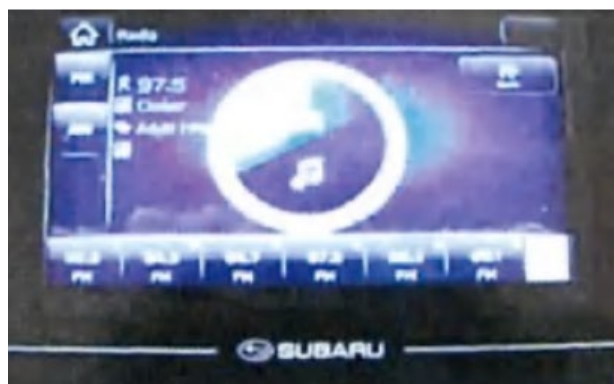
- 3) The time in the MFD automatically reverts to a “default” setting, even after setting the time using “Manual” mode.
- 4) Audio volume goes to maximum automatically after one click of the volume up button on the steering wheel. In some cases, this condition may also occur without input from the operator. Maximum volume is also displayed on the screen.

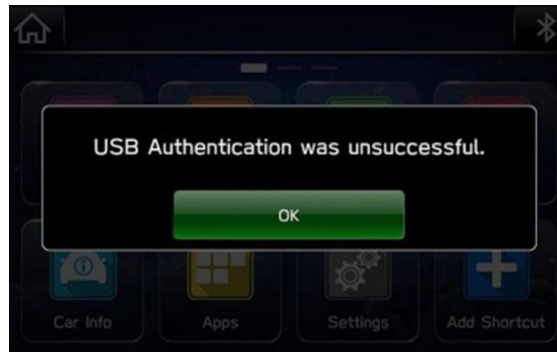
NOTE: If an attempt is made to install the wrong “grade” file into the wrong grade head unit (EXAMPLE: “Base” update file into a “Mid” or “High” head unit), the USB Authentication error screen below will be displayed:
