January 22, 2019

Version 1

2019 RDX: Booming Noise and Engine Idles Rough on Cold Starts

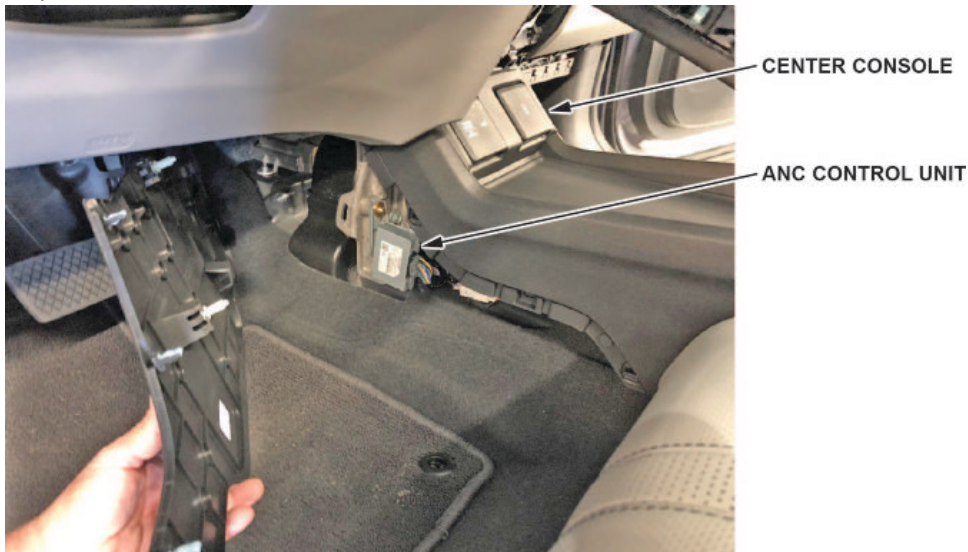
The ANC control unit becomes unstable when the idle fluctuates.

1. Replace the active noise control unit located under the driver's side center console.
