# IMPORTANT SAFETY RECALL

Bulletin Number: NHTSA Recall 18V-832  
Product Line: 2019 Airstream Interstate 19  
Subject: Incorrect Battery Fuse

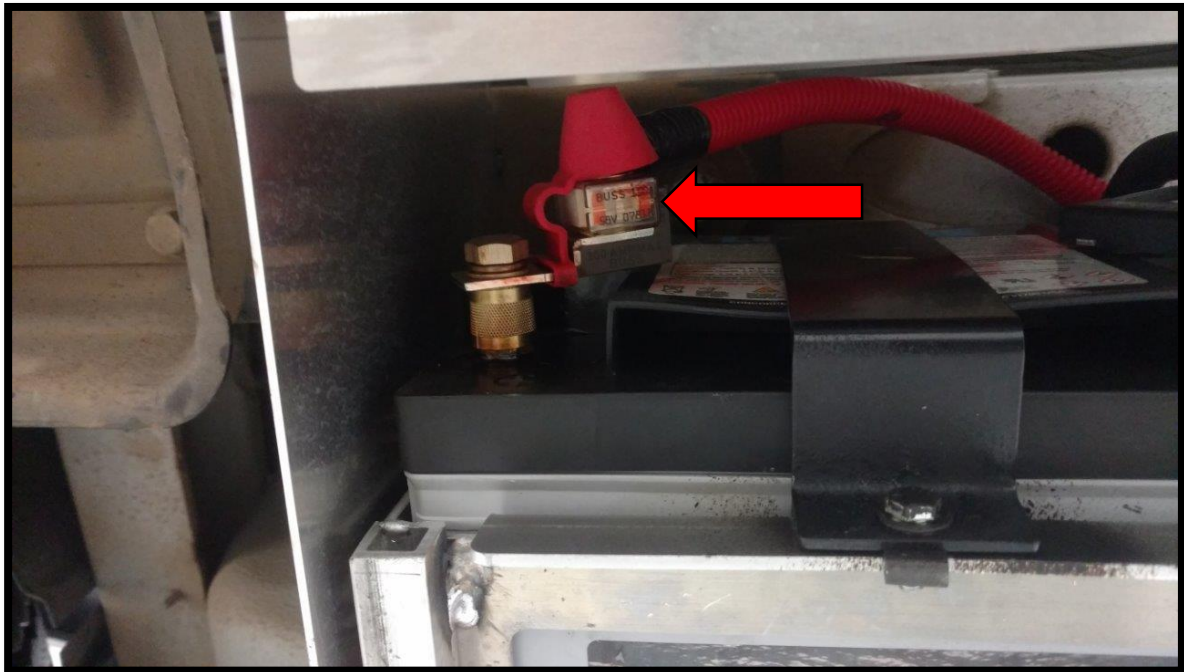
Incorrect coach battery fuses were installed on the initial Interstate 19 production units which may cause an overloaded battery cable condition. The initial units have a 150 Amp fuse installed on both the coach batteries instead of the correct 100 Amp fuse that was required.

**Step 5:** Disengage the red rubber cap and, using the 13mm wrench, remove the containment nut on the positive fuse. Remove lock washer, flat washer and positive cable from the fuse side stud.

Then remove the 150Amp fuse and replace with 100Amp fuse.

Reconnect the positive cable, flat washer, lock washer and nut on the 100 Amp fuse. Using the inch lb. torque wrench, torque nut to 70 inch lbs.
