MODEL
2011MY
Optima Hybrid
(TF HEV)

NUMBER
019

TECHNICAL SERVICE BULLETIN

SUBJECT: SERVICE ACTION: OPTIMA HEV HYBRID COOLING
FAN RESISTOR REPLACEMENT (SA094)

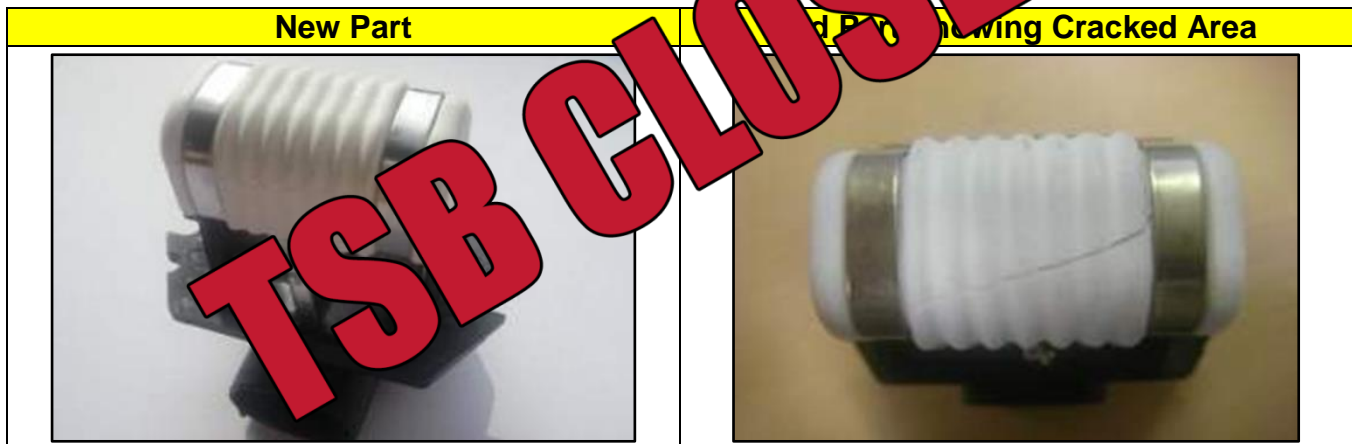
This bulletin provides information about some Optima Hybrid vehicles produced from Job #1 to September 17, 2011 where the cooling fan resistor might crack. If the cooling fan resistor is cracked, the cooling fan operation may be affected. To ensure maximum customer satisfaction Kia is requesting the completion of this Service Action on all affected 2011MY Optima Hybrid vehicles. Before conducting this Service Action, verify that the VINs included in the list of the affected VINs.
