MODEL
2018MY
Stinger (CK)

NUMBER
074 (Rev 2, 01/30/2019)

TECHNICAL SERVICE BULLETIN

SUBJECT: SERVICE ACTION: THETA 2.0L TURBO ATF WARMER
CONNECTOR REPLACEMENT (SA333)

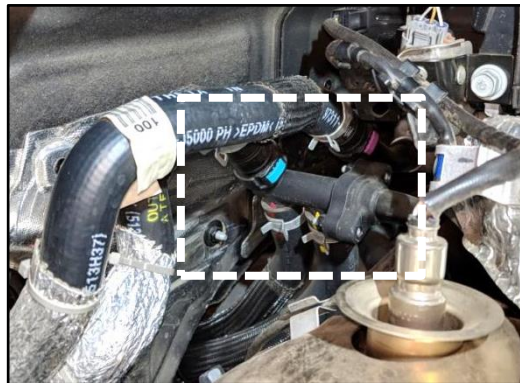
This bulletin provides the procedure to replace the Automatic Transmission Fluid (ATF) warmer connector on some 2018MY Stinger (CK) vehicles, equipped with the Theta 2.0L Turbo engine and produced from September 9, 2017 through January 4, 2018, which may exhibit a coolant fluid leakage between the ATF connector and engine side heater pipe. Follow the procedure outlined in this bulletin to replace the ATF warmer connector. Kia is requesting the completion of this Service Action on all affected vehicles including dealer stock, prior to delivery. Before conducting the procedure, verify that the vehicle is included in the list of affected VINs.
