**Mack Models**

**Volvo Models**

| Title | Diagnostic Trouble Codes (DTC) P0194-00 - Fuel Rail Pressure Sensor, Circuit Erratic, Intermittent And/Or P016E-00 Closed Loop Fuel Pressure At Control Limit, Pressure Too High - <b>US17+OBD16 (Common Rail Fuel System) Emissions And Newer; Model Year 2018 And Newer</b> |

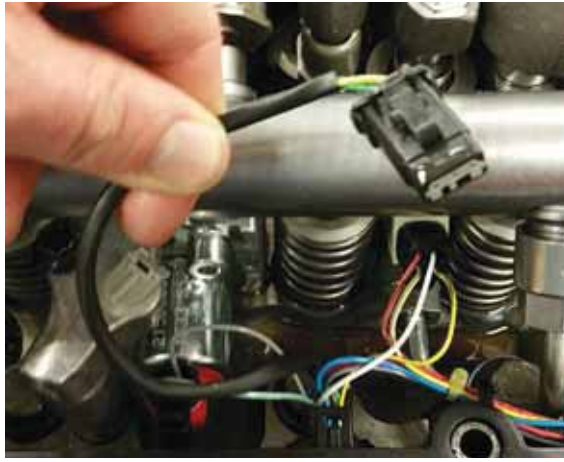
Rail Pressure Sensor Harness

| Cause | Common Rail Engines may generate DTCs P0194-00 Fuel Rail Pressure Sensor ( RPS ) and/or P016E-00 Closed Loop Fuel Pressure At Control Limit, Pressure Too High due to wear of the sensor and wire harness terminals. Due to the nature of the fault it may be difficult or not possible to duplicate the symptoms. |

**l** 1. Replace both of the following parts:

**t** • The Fuel Rail Pressure sensor.

**i** • The short internal wiring harness that runs between the connector on the lower section of the two-piece valve cover  
**o** and the pressure sensor.
