ITB17-042b

January 29, 2019

INFINITI; DTC P0456 CAUSED BY EVAP LEAK AT VENT CONTROL VALVE O-RING

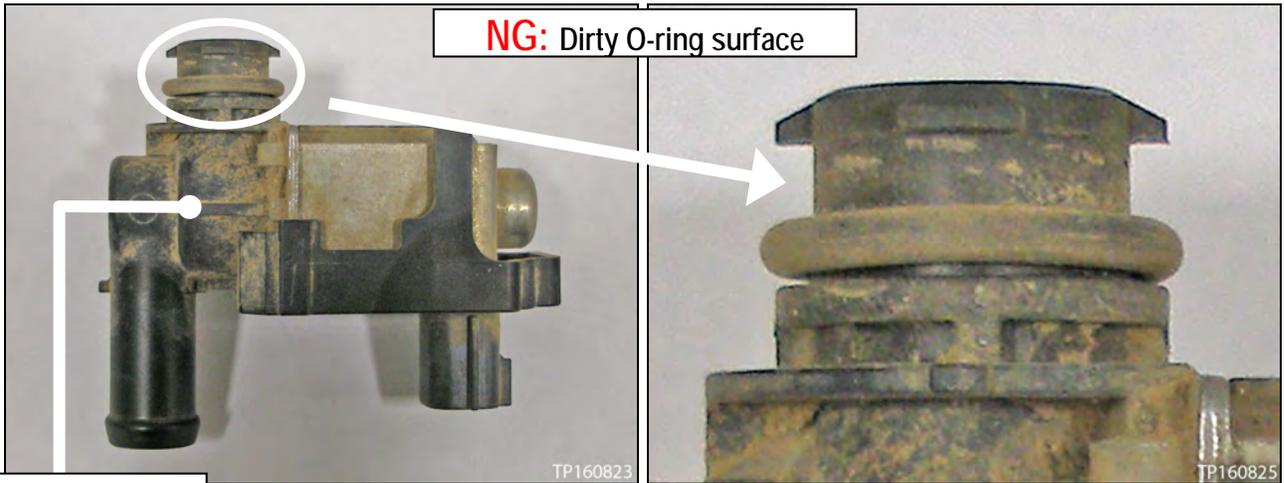
Vent control valve

Where vent control valve mounts in canister

- To access the O-ring, refer to the appropriate section in the Electronic Service Manual (ESM) of the **APPLIED VEHICLE** for vent control valve removal and installation.
- This O-ring is now available separately (see **PARTS INFORMATION**).
- When installing, do not add any lubrication to the O-ring.
- Seat the O-ring all the way down as shown on page 4, Figure 7.
 - Having the O-ring seated all the way down will assure it is not twisted or rolled over.
- Refer to the pictures on pages 3 and 4 for additional installation information.

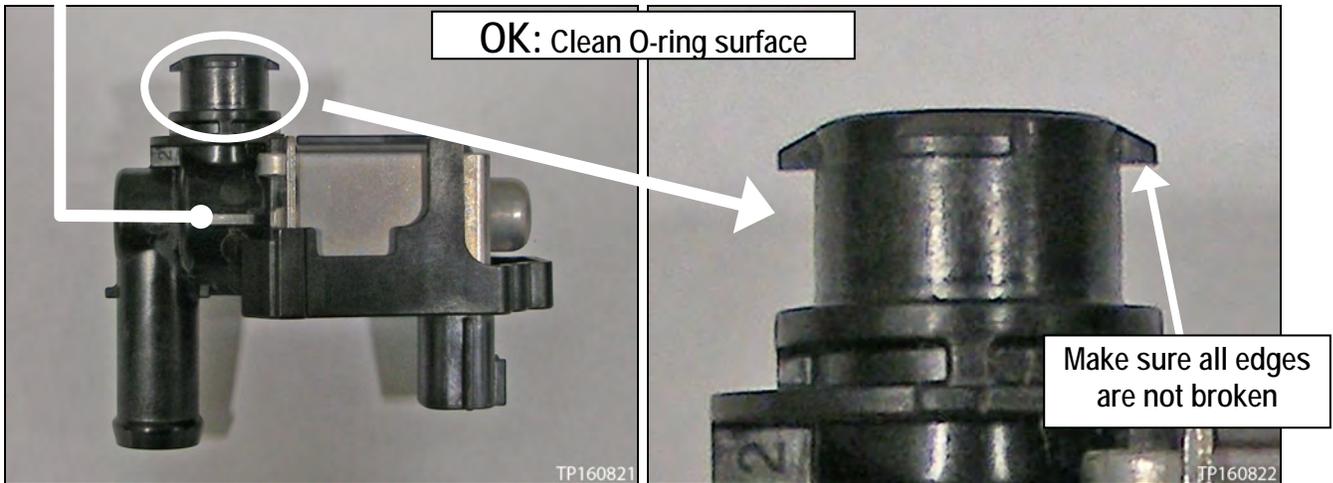
Canister

This surface must be clean all around

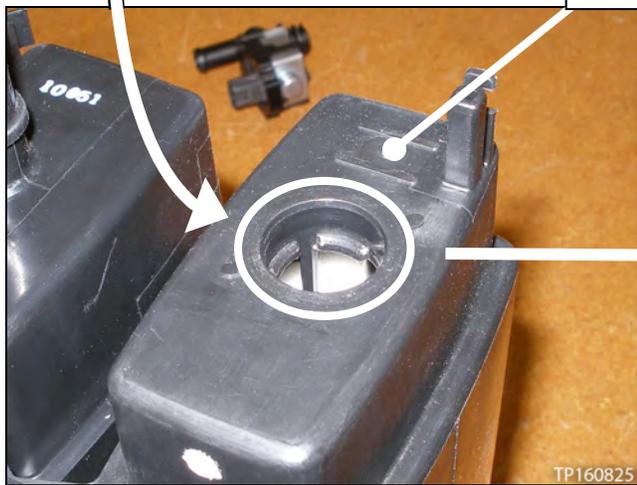
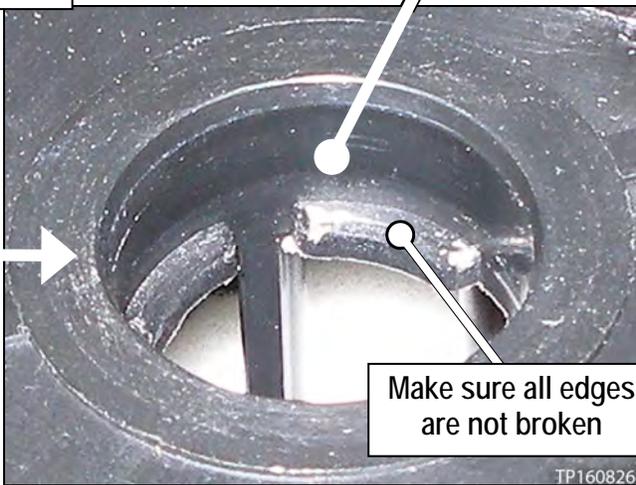
Make sure all edges are not broken

When fully seated (no gaps), O-ring is not twisted or rolled over

No gap all around

- Make sure the surfaces that the O-ring comes in contact with are clean.
- When installed, make sure the O-ring is not twisted or rolled over.
- Verify the repair is complete by checking for leaks with a “smoke” leak detection machine or CONSULT-III plus (C-III plus).
 - If a “smoke” leak detection machine is used, follow the manufacturer’s operating instructions.
 - If C-III plus is used:
 1. Confirm the fuel filler cap is secure.
 - Vehicles **with** a service port see page 5.
 - Vehicles **without** a service port see page 6.
 2. Using Active Test, close the vent control valve.
 3. Apply pressure using J-42909 until the bar graph reaches about halfway.
 4. Monitor the bar graph for 10 minutes.

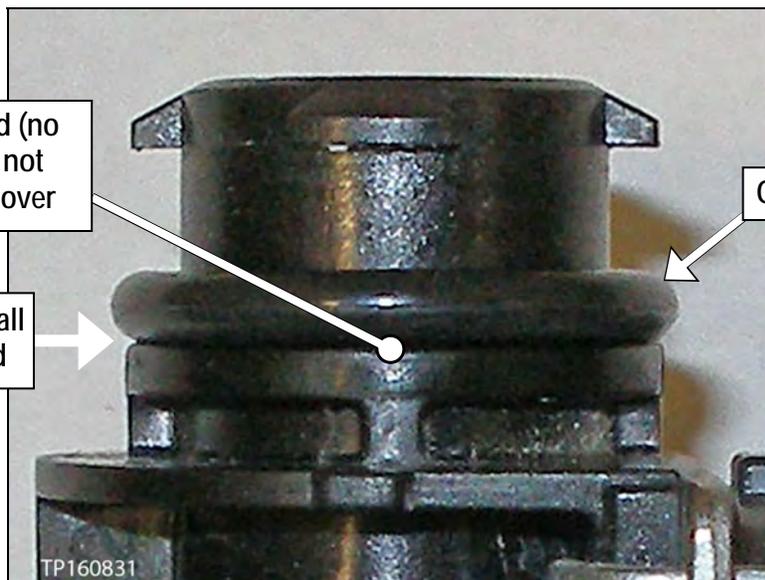
Figure 7

O-ring
