SERVICE BULLETIN

Classification: EC15-017a	Reference: NTB15-108a	Date: January 17, 2019
------------------------------	--------------------------	---------------------------

NV200 AND TAXI; MIL ON WITH DTC P0101

APPLIED VEHICLES: 2013-2019 NV200 (M20)
2014-2017 and 2019 Taxi (M20)

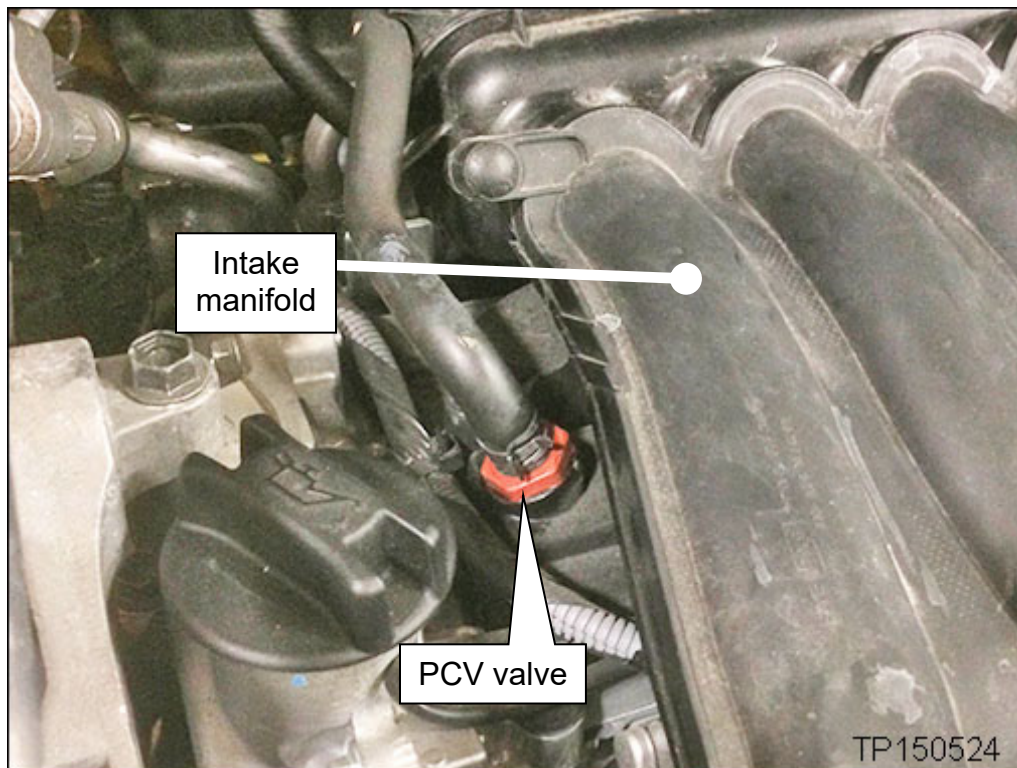
Figure A

1. Open the hood and confirm the color of the PCV valve (see Figure A).
 - If the PCV valve is orange, go to step 2.
 - **NOTE:** Orange PCV valves were installed on 2014-2015 Taxi only.

- If the PCV valve is black, skip to step 4.
2. Replace the PCV valve with the one listed in **PARTS INFORMATION**.
3. 2014-2015 Taxi: Check the ECM part number for possible ECM reprogramming (see page 4):

- If ECM reprogramming applies: Reprogram the ECM, repairs are complete.
 - If ECM reprogramming does not apply: Skip to step 6.
4. Inspect the PCV valve per the ESM.

- If NG, go to step 5.
 - If OK, STOP HERE. Refer to ASIST and the ESM for DTC P0101 diagnosis.
5. Replace the PCV valve with the one listed in **PARTS INFORMATION**.

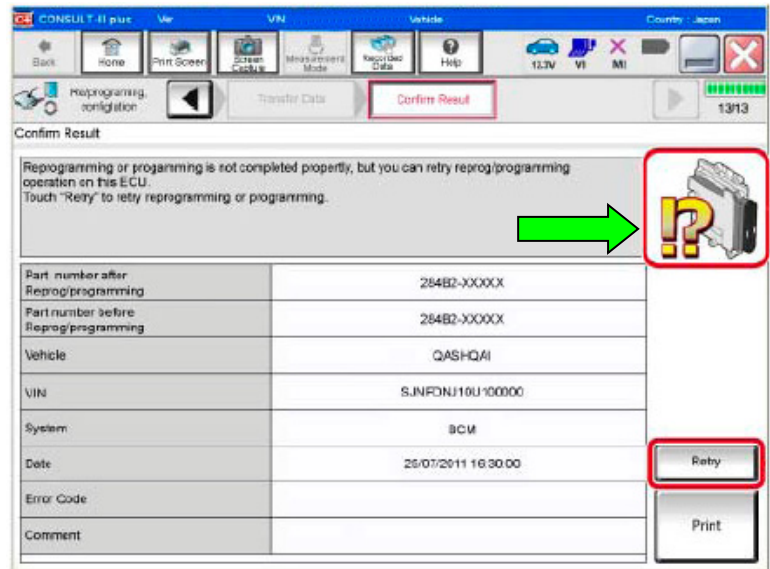
Figure 5

If reprogramming does not complete and the “!” icon displays as shown in Figure 5:

- Check battery voltage (12.0–15.5 V).
- Ignition is ON, engine OFF.
- External Bluetooth® devices are OFF.
- All electrical loads are OFF.
- **Select retry and follow the on screen instructions.**
- “Retry” may not go through on first attempt and can be selected more than once.

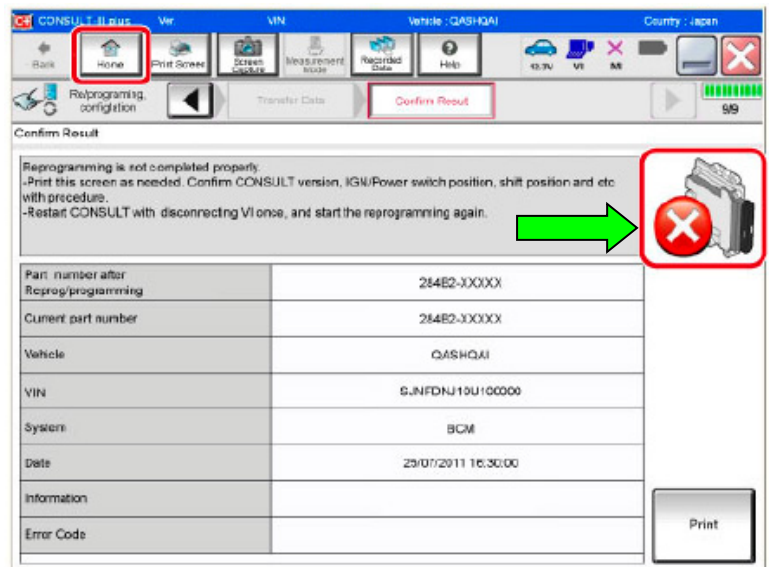
Figure 6

If reprogramming does not complete and the “X” icon displays as shown in Figure 6:

- Check battery voltage (12.0 – 15.5 V).
- CONSULT A/C adapter is plugged in.
- Ignition is ON, engine OFF.
- Transmission is in Park.
- All C-III plus / VI cables are securely connected.
- All C-III plus updates are installed.
- **Select Home, and restart the reprogram procedure from the beginning.**
