# Air Conditioning System - Improved Component Inspection

Toyota

In certain cases of leaking air conditioning systems, the root cause of the leak is inadvertently overlooked, causing a repeat repair. To improve customer satisfaction and repair A/C system leaks in one dealer visit, Toyota has developed a set of guidelines for evaluating A/C system components.

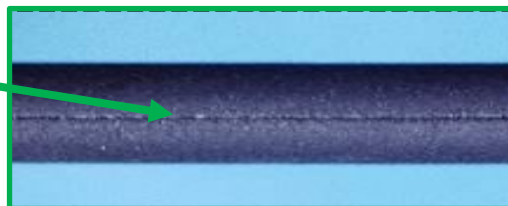
**OK Part\*** - Line at middle of O-ring is straight with no deformation. No tears, or crushed areas.  
 \*O-rings should be replaced anytime they are removed from a pipe/component to prevent leaks and foreign material.

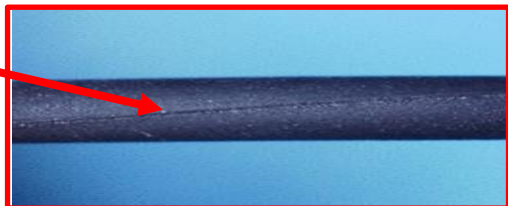
**Twisted O-Ring – No Good Part**  
 Line at middle of O-ring is not straight.

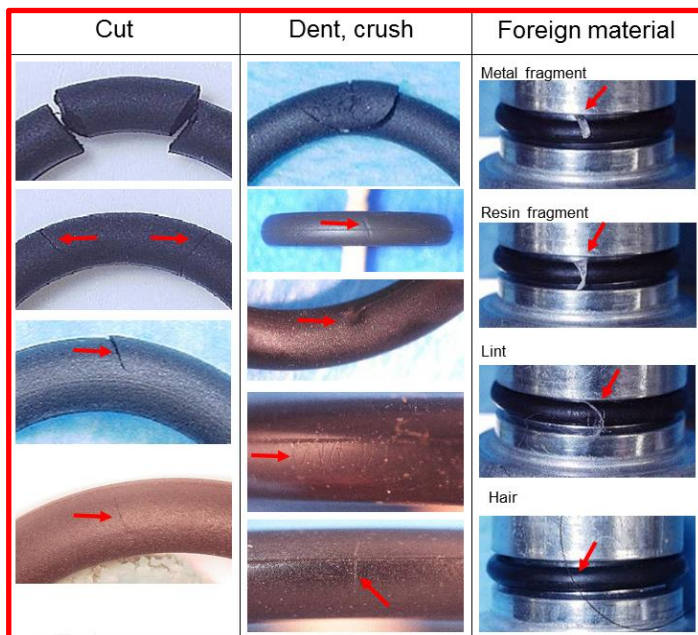
**Cut/Dent/Crush – No Good Part**  
 O-ring damaged by another component. Replace O-ring, proceed with A/C Pipe Inspection.

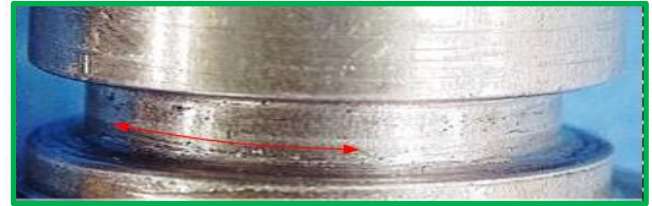
**OK Part** - Light scratching parallel with O-ring groove. This is caused by normal part processing. Pipe is ok to reuse.

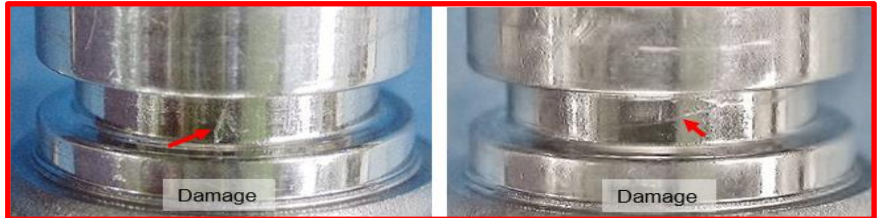
**Damage – No Good Part**  
Pipe is damaged due to deep scratching or gouge of base metal. Pipe replacement is recommended to prevent repeat repair.

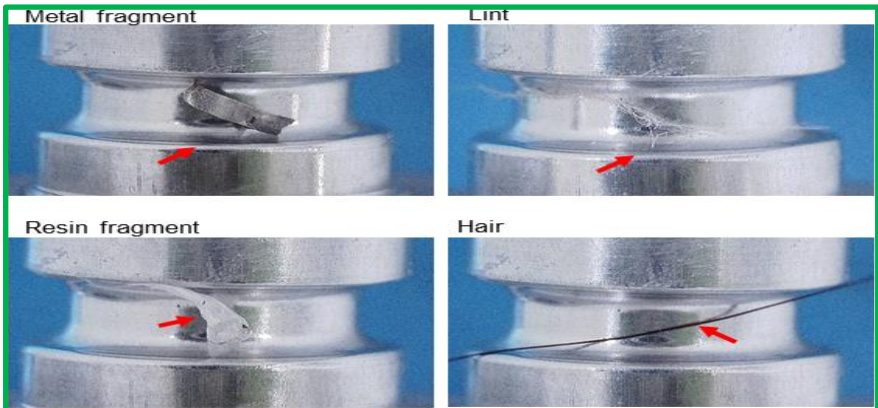
**Foreign Material – OK Part**  
Pipe has foreign material stuck to it. Material can be cleaned off using a non-metallic tool and the pipe is ok to be reused.

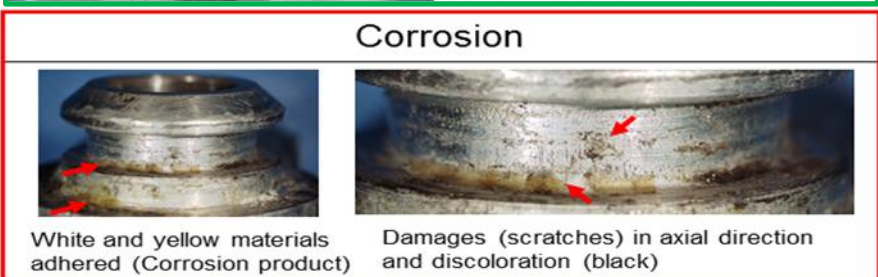
**Corrosion – No Good Part**  
Pipe is damaged due to corrosion of base material. Pipe replacement is recommended to prevent repeat repair.

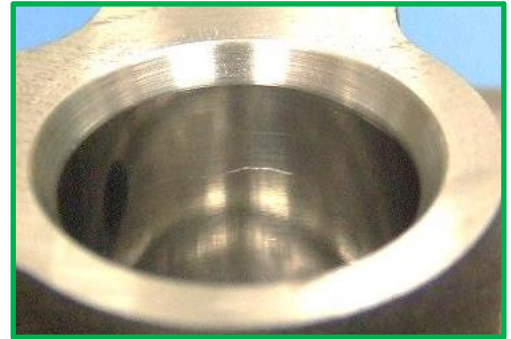
**OK Part** - Light scratching parallel with O-ring groove.  
This is caused by normal part processing. Compressor is ok to reuse.

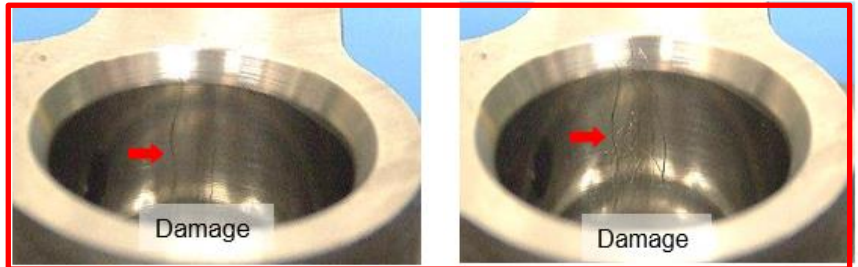
**Damage – No Good Part**  
Compressor seal bore is damaged due to deep scratching perpendicular to O-ring groove.

Compressor replacement is recommended to prevent repeat repair.

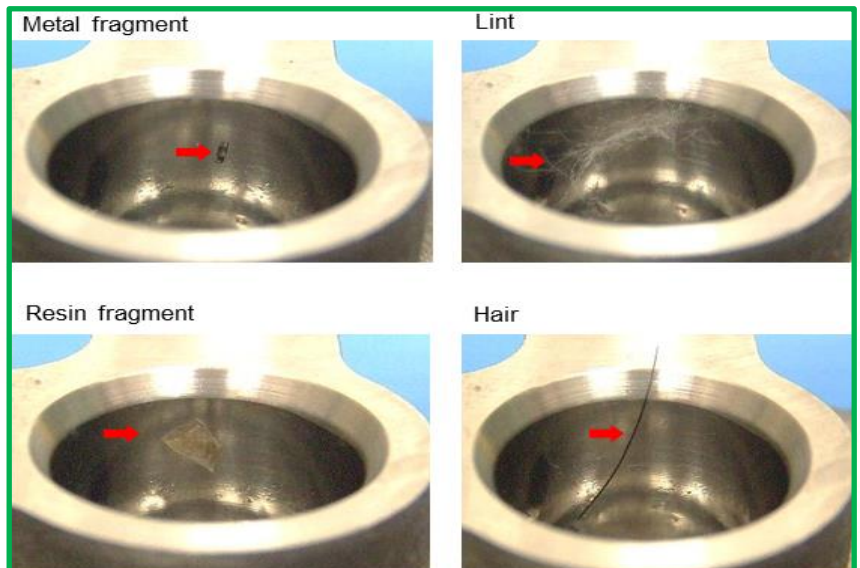
**Foreign Material – OK Part**  
Compressor has foreign material stuck to seal bore.

Material can be **carefully** cleaned off using a non-metallic tool and the compressor is ok to be reused.

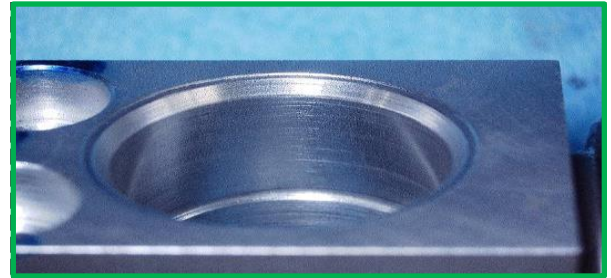
**OK Part** - Light scratching parallel with O-ring groove. This is caused by normal part processing. Expansion valve is ok to reuse.

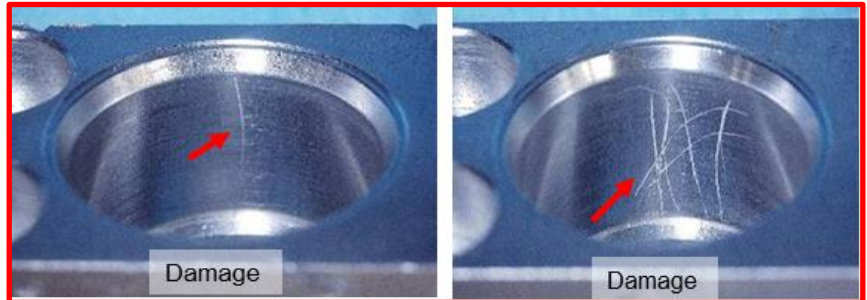
**Damage – No Good Part**  
Expansion valve seal bore is damaged due to deep scratching perpendicular to O-ring groove.

Expansion valve replacement is recommended to prevent repeat repair.

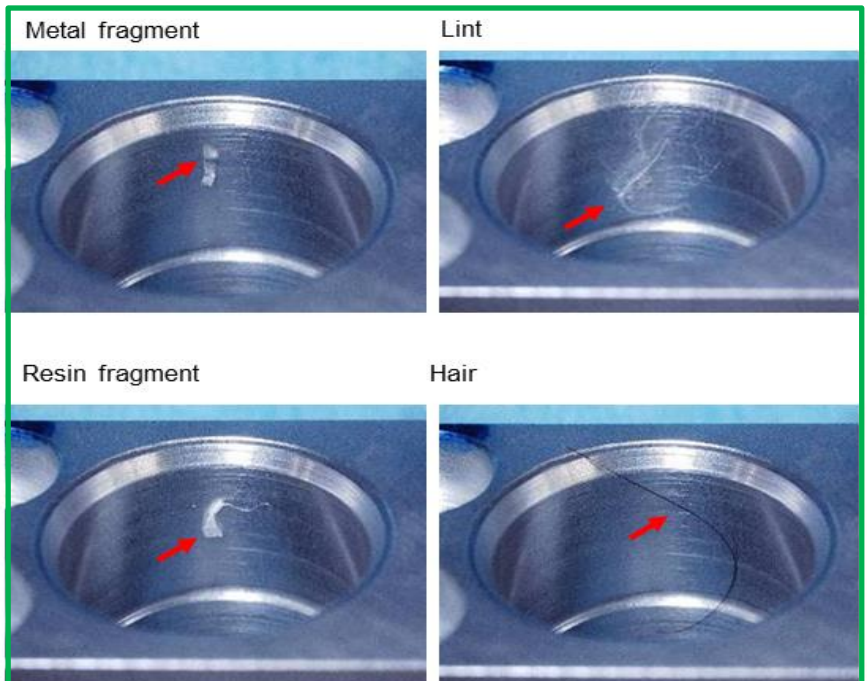
**Foreign Material – OK Part**  
Expansion Valve has foreign material stuck to seal bore.

Material can be **carefully** cleaned off using a non-metallic tool and the expansion valve is ok to be reused.

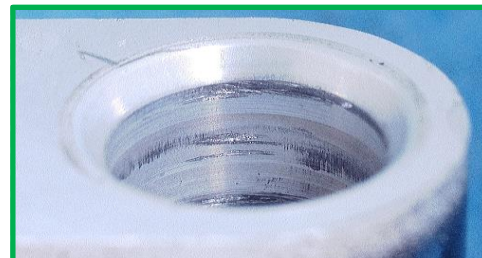
**OK Part** - Light scratching parallel with O-ring groove. This is caused by normal part processing. Condenser is ok to reuse.

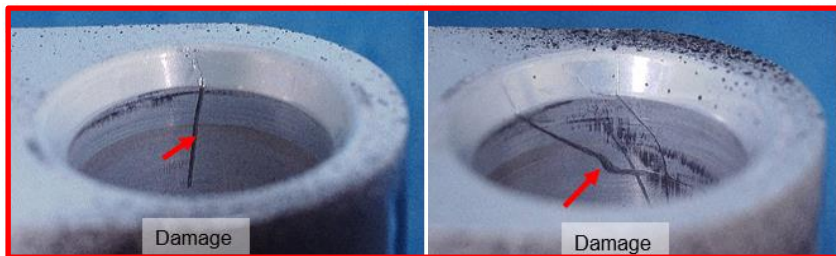
**Damage – No Good Part**  
Condenser seal bore is damaged due to deep scratching perpendicular to O-ring groove.

Condenser replacement is recommended to prevent repeat repair.

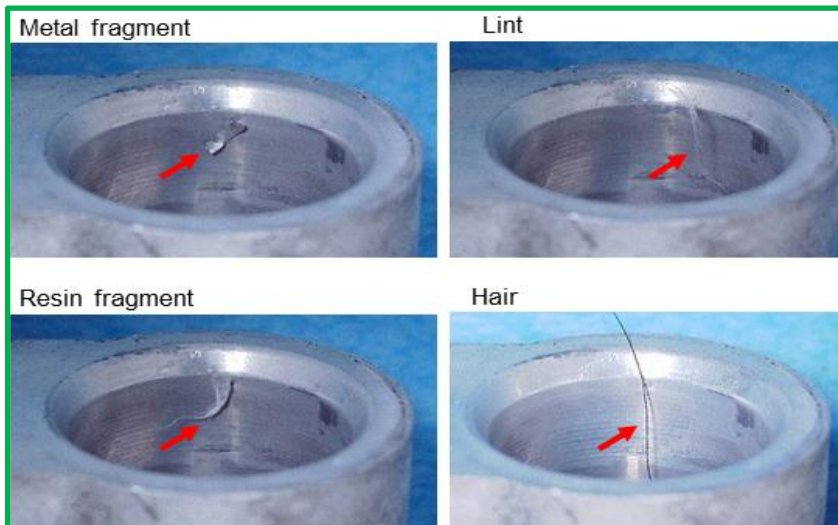
**Foreign Material – OK Part**  
Condenser has foreign material stuck to seal bore.

Material can be **carefully** cleaned off using a non-metallic tool and the condenser is ok to be reused.

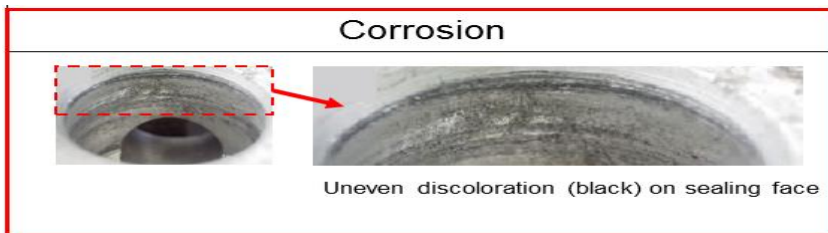
**Corrosion – No Good Part**  
Seal bore is damaged due to corrosion of base material.

Condenser replacement is recommended to prevent repeat repair.
