Mazda North American Operations Irvine, CA 92618-2922

Subject: APPLE CARPLAY™ / ANDROID AUTO™ FREQUENTLY ASKED QUESTIONS (FAQ)	Service Alert No.: SA-001/19	
	Last Issued: 01/04/2019

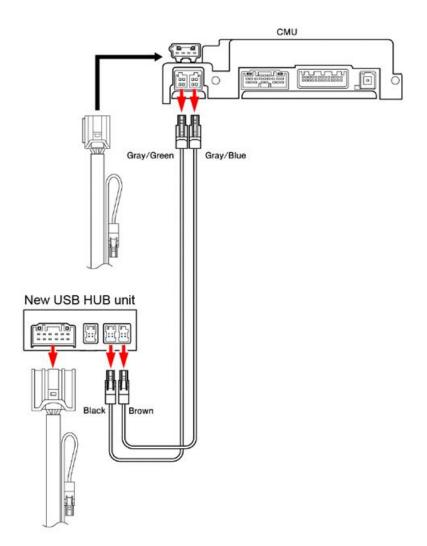
(Cannot install CMU software after USB Cable Set Kit (P/N C922-V6-605) installation)

1. Disconnect the new USB HUB unit and the new USB cables from the CMU.
