# Technical Service Bulletin

**ROUGH IDLE AND/OR MIL ON WITH DTC P0300, P0301, P0302, P0303  
OR P0304 IN COLD TEMPERATURE**

**Bulletin No.:** 01-007/19

**Last Issued:** 01/24/2019

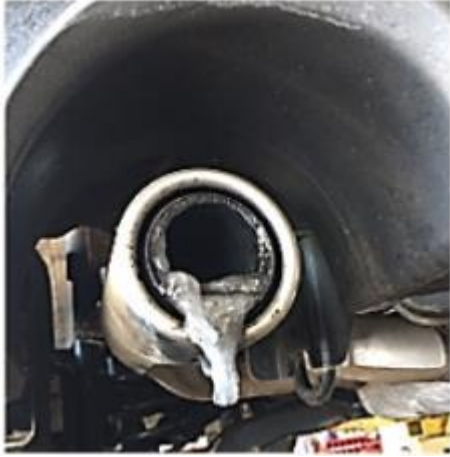
This may be caused by frozen water accumulated in the main silencer, restricting exhaust flow.

2. Replace the main silencer according to the instructions on MGSS online:

**NOTE:** The modified service parts have two (2) drain holes at the bottom of the main silencer.
