JTB00552NAS7

TECHNICAL BULLETIN

02 JAN 2019

InControl® Touch Pro™ Features May Not Function As Expected

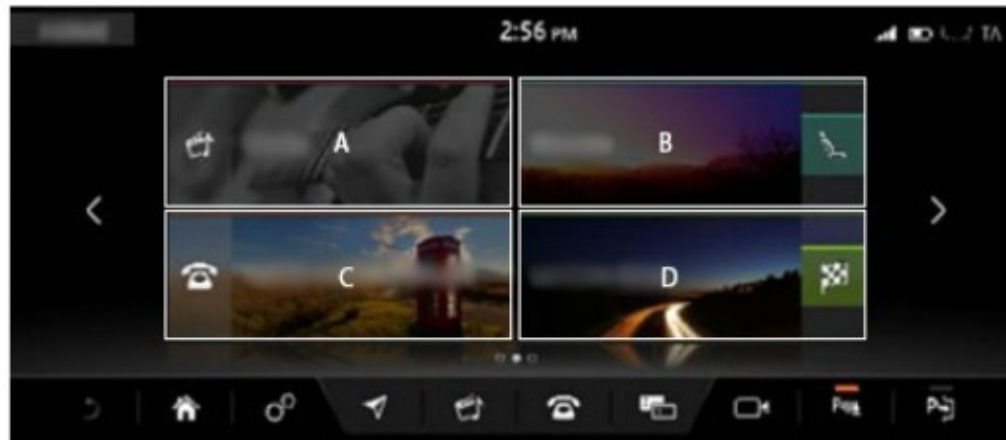
E229092

Vehicles with Single-Screen System current 4-tile home screen:

- **A** - Media
- **B** - Climate
- **C** - Phone
- **D** - Navigation

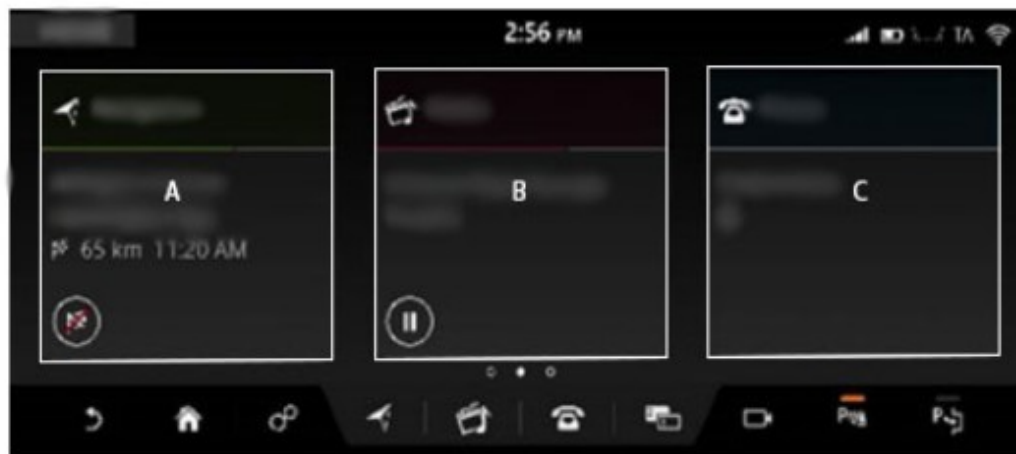
E229093

Vehicles with Single-Screen System updated 3-tile home screen:

- A - Navigation
- B - Media
- C - Phone
