JTB00670NAS1

TECHNICAL BULLETIN

Water Leak Into Front Footwell(s)

MODEL:	MODEL YEAR:	VIN:
XE (X760)	2017	921222-995971
XE (X760)	2017-2018	P10168-P35418
XF (X260)	2016-2018	Y00461-Y66000

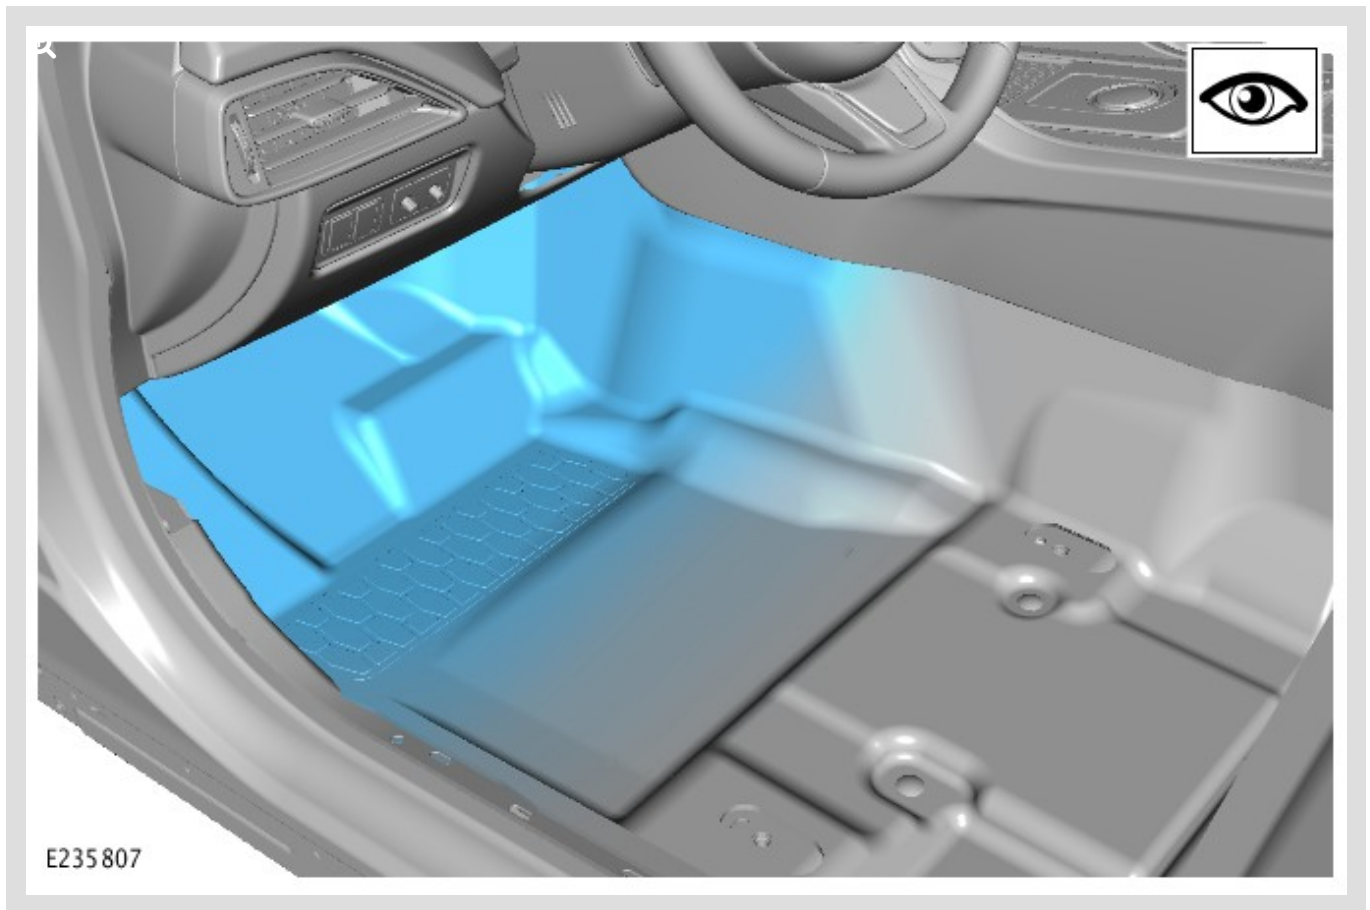
2

Inspect the front left and right footwell carpet for water ingress.

- If the carpet(s) does not show evidence of water ingress, do not continue with this Technical Bulletin as the customer concern is not directly related to its content.

- **Only if required:** submit a TA (Technical Assistance) request for further assistance.
- If the carpet(s) does show evidence of water ingress, go to the Workshop Procedure below.

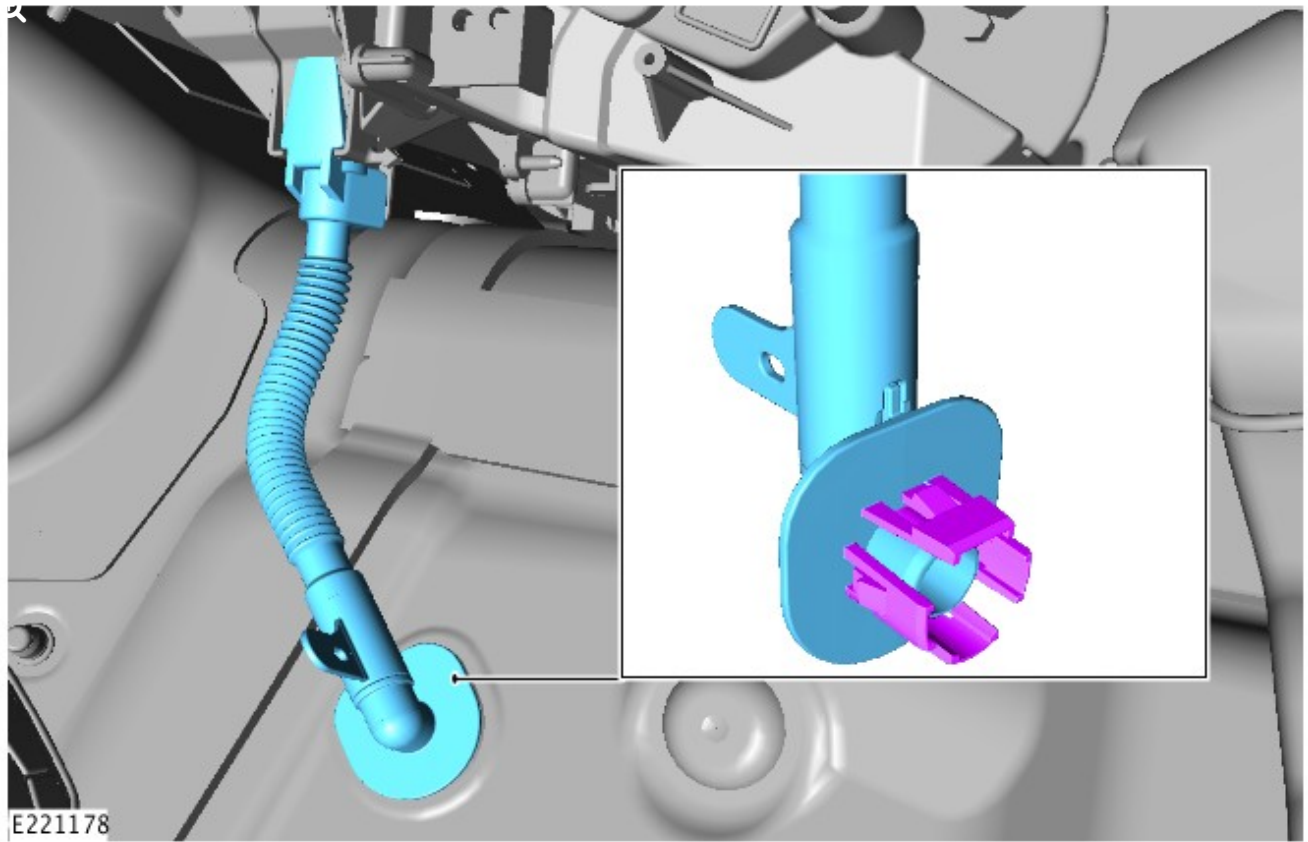
4

This may be caused by insufficient sealing of the climate control system drain tube.

Remove and discard the left drain tube.
