# Technical Service Bulletin

<b>Subject:</b>  <b>A/C BLOWS WARM AIR DUE TO REFRIGERANT LEAK FROM CONDENSER</b>	<b>Bulletin No.:</b> 07-001/19
	<b>Last Issued:</b> 01/11/2019

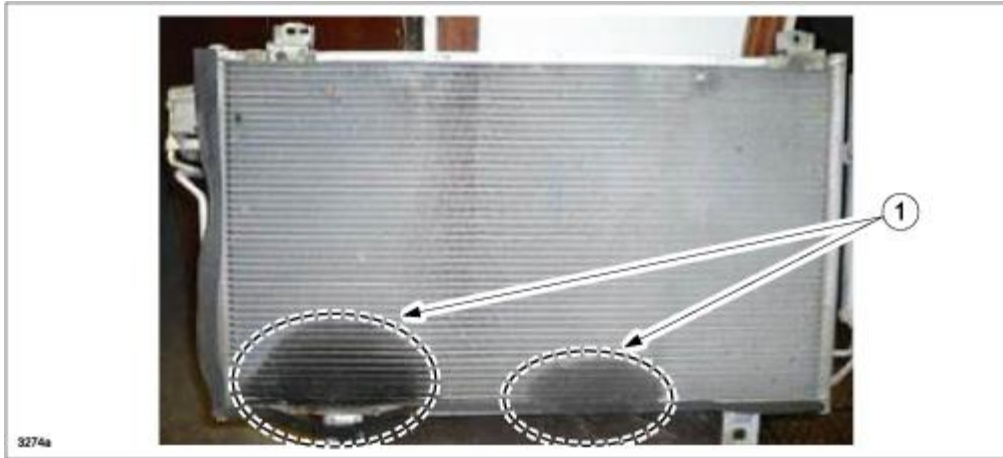
Some customers may complain about warm air from the climate control vents when the air conditioner is ON. This may be caused by condenser corrosion, causing a refrigerant leak.

1. Verify the customer concern.
2. Visually inspect the condenser for A/C refrigerant leak.
  - Is there a visible trace of A/C refrigerant leaking at location (1)?

- Yes - Go to step 4.
  - No - Go to step 3.
3. Use a dealer supplied UV leak detection tool. Is there a trace of fluorescent liquid at location (1)?

- Yes - Go to step 4.
  - No - This Service Information is not applicable. Refer to MGSS online Workshop Manual (NO COOL AIR [FULL-AUTO AIR CONDITIONER]).
4. Replace the condenser according to the instructions on MGSS online (CONDENSER REMOVAL/INSTALLATION [SKYACTIV-G 2.0]).
  5. Verify the repair.
