Technical Service Bulletin

Subject: CONDENSATION / FOG IN FRONT AND REAR COMBINATION LAMPS (HEADLAMP AND TAILLAMP ASSEMBLIES)	Bulletin No.: 09-003/19
	Last Issued: 01/03/2019

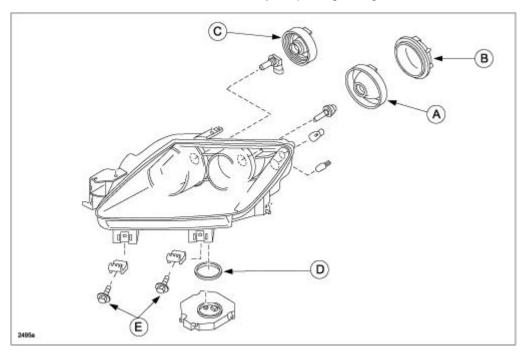
When dealing with customer complaints of excessive condensation and/or water within the headlamp unit, first determine if all the bulb sockets (including O-ring), seals and covers are present and correctly installed. In most cases you will find that the Bulb Seal No. 1 (A) or HID Bulb Seal No. 1 (B) and Bulb Seal No. 2 (C) socket covers have not been correctly installed or are missing due to improper prior repairs (i.e., customer replacing the headlamp bulbs or body shop not transferring them when replacing the headlamp unit(s) due to a collision). Any damage caused by missing socket covers, HID module seal (D), or missing bumper brackets (E) is not covered by warranty policy. If none of these issues exists, explain to the customer that this is a natural phenomenon and not a quality defect. DO NOT attempt repairs as this is considered normal, and is NOT covered under Warranty. Replacing the light unit will not correct this symptom.

NOTE: LED headlamp assembly with LED turn signal lamp replacement part include seals. Seal transfer is not required.

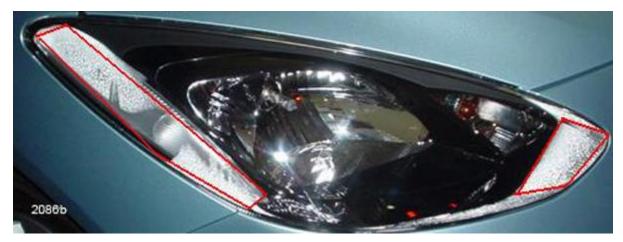
Condensation/fogging along the edges and in the corners is considered normal.

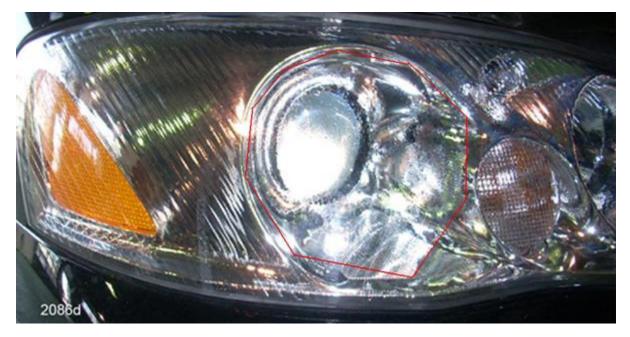
Some condensation/fogging on the lens is considered normal.

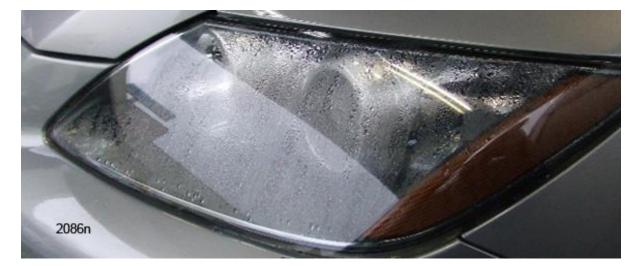
Examples of Light Units With Condensation/Fog That Should Be Replaced Heavy/large amount of condensation on the lens is not normal.

- The location where the bulbs are fitted has a high air volume with good air circulation, therefore, if a large or heavy amount of condensation appears here, the light unit should be replaced. A small amount of condensation here is considered normal and should clear after the lights have been on for some time and the light unit should not be replaced. Refer to the following pictures for examples.
- If the outside conditions are unfavorable (cold and damp), even fog (dew concentration) as shown in the following pictures will take some time to clear up. Therefore, be careful in making a decision. A picture will be required with every claim for Warranty. If a light unit is found with no problem, and no picture is sent in, the claim may be later debited. You can also perform the following test to determine if the light unit should be replaced.
