Technical Service Bulletin

Subject: STAINS FOUND ON PAINT DURING PDI	Bulletin No.: 09-008/19
	Last Issued: 01/14/2019

2017-2019 MX-5
2017-2019 CX-3
2017-2019 CX-5
2017-2019 CX-9
2017-2019 Mazda3
2017-2019 Mazda6

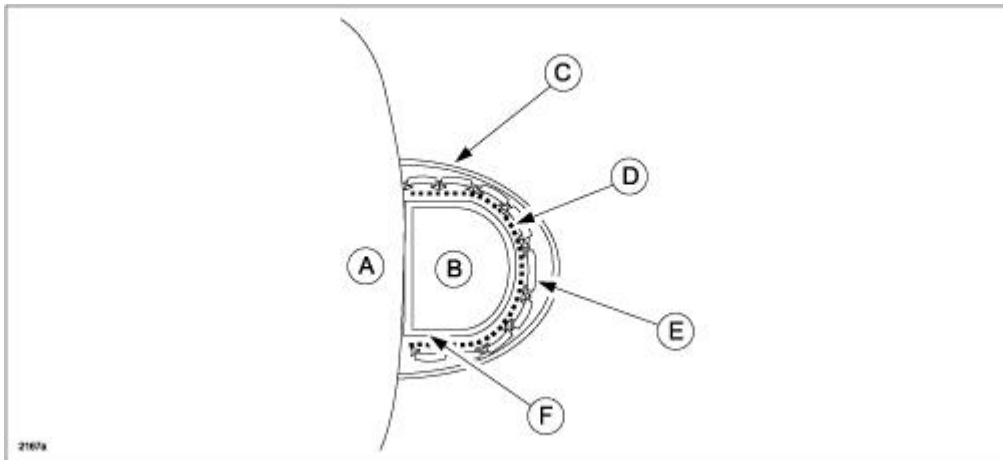
2. Insulate all plastic and rubber parts (as shown below) using heat insulation materials (C ~ F) prior to beginning the application of heat.

A - Body Panel

B - Molding

C - Aluminum foil covering all area

D - Wet towel

E - Folded aluminum foil

F - Aluminum foil tape

- Since this repair procedure requires the use of heat from a heat gun or infrared drier, be sure to insulate all rubber or plastic parts which are easily affected by heat from near the affected stain area.
- Use extreme care to ensure the top coat surface temperature stays below 284°F (140°C).
- To protect materials inside the cabin area (i.e. carpet, seats, etc.), also place insulation over the glass as necessary.

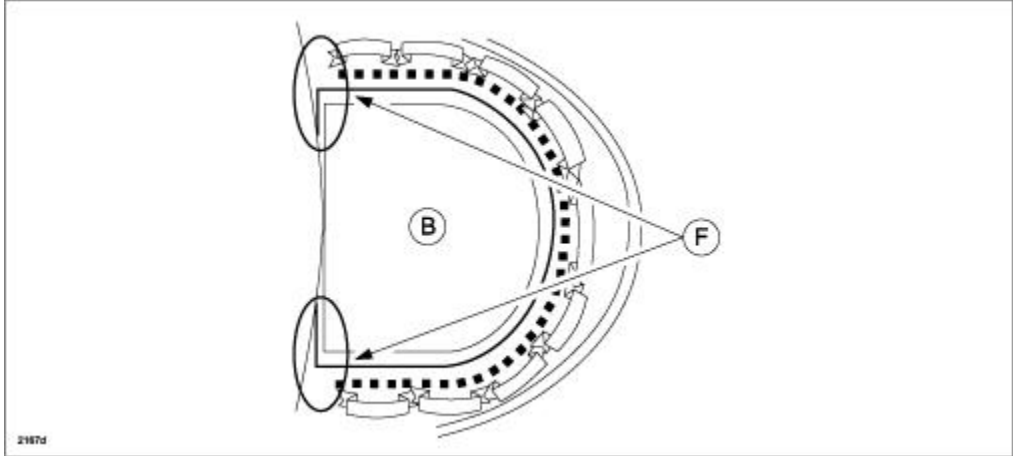
NOTE: Ensure the aluminum foil tape (F) is inserted into the edges of the molding (B) as shown below.

CAUTION: Refer to “PLASTIC PARTS HEAT RESISTING TEMPERATURE” section of the applicable Body Shop Manual before the repair. Repair and replacement of damaged plastic parts due to over-heating is not covered under warranty.

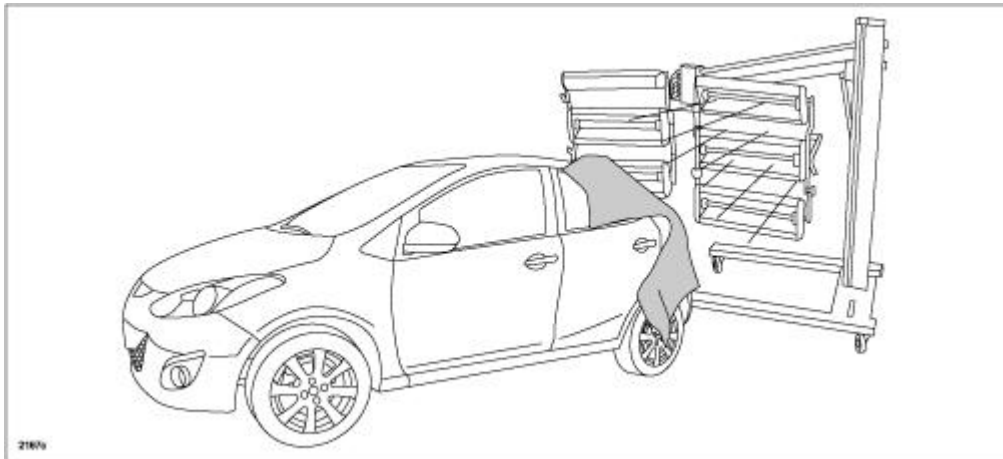
6. Mount an infrared drier approx. 31.5 inches (80 cm) away from the surface of the stained area.

7. Set the temperature of the infrared drier to 140~158° F (60~70° C) and apply heat for a maximum of **60 minutes**.

CAUTION: DO NOT apply heat for more than 60 minutes or damage to the body panel surface, plastic or rubber parts may occur.
