# Replace Huck BOM Fastener on Front Seats

**Classification** Repair Bulletin    **Section/Group** 13 - Seats    **Country/Region** All

**Year** 2015-2018    **Model** Model S, Model X    **Version** All

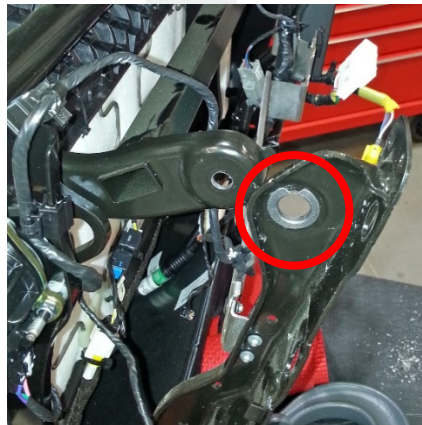
**Figure 13**

**NOTE:** The newly formed flange might or might not be split, as shown in Figure 13.

- h. Apply the C-clamp and tighten to flatten the flared part of the bushing body to form a flange on the outboard side of the seat track (Figure 13).
