Audio Unit Restarts On Its Own or CarPlay Does Not Work after iPhone Update

Supersedes 18-060, dated October 26, 2018, to revise the information highlighted in **yellow**

AFFECTED VEHICLES

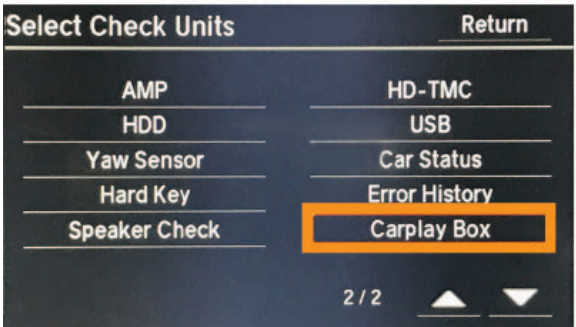
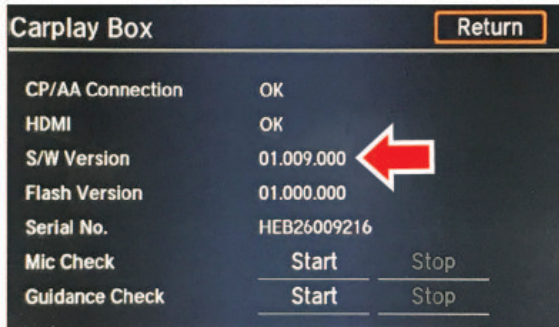
8. Press the down arrow to go to page 2, then select **Carplay Box**. If the S/W Version shows **02.012.000** or lower, proceed with the update.

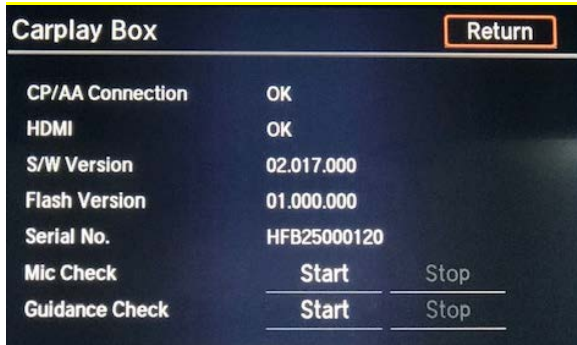
1. Enter the **Select Diagnosis Items** screen by pressing and holding the **BACK + INFO +** and **SETTINGS** icons. Then select **Detail Information & Setting**.
2. Select **Unit Check**.
3. Press the down arrow to go to page 2, then select **Carplay Box**. Confirm that the S/W Version **02.017.000** is displayed.
