SI B51 30 18  
Body Equipment

## GROANING NOISE FROM THE CENTER CONSOLE

F80 (M3)	F82 (M4 Coupe)	F83 (M4 Convertible)	
----------	----------------	----------------------	--

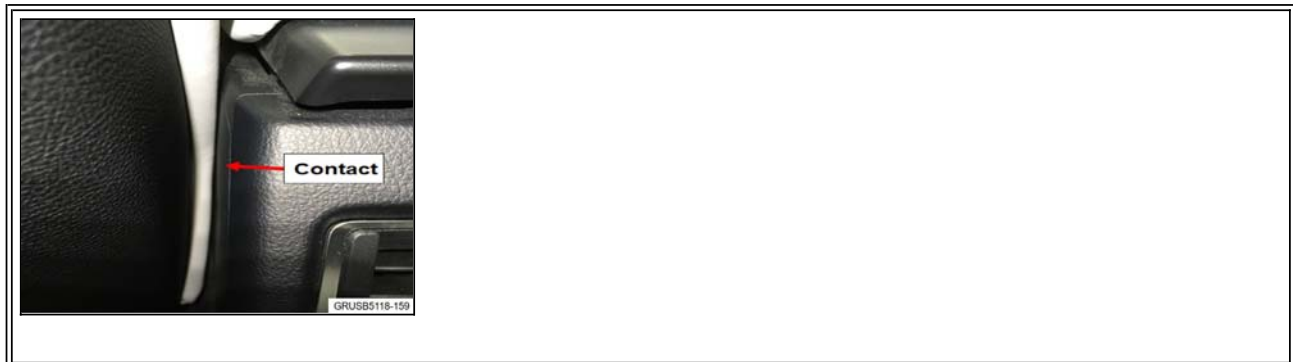
The center console is not positioned correctly between the front seats, allowing the side of one of the front seats to rub against the console.

Adjust the center console position. If needed, adjust the position of one or both front seats.
