SI B51 32 18
Body Equipment

PAINT ON THE B-PILLAR IS SCRATCHED/DAMAGED

G14 (8 Series Convertible)	G15 (8 series)
----------------------------	----------------

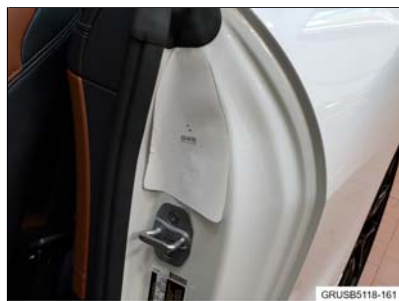
The paint finish of the door jamb (above the door striker) is scratched due to the inner door cavity window seal.

The door window cavity seal rubber is abrasive and may scuff the door jamb area when opening and closing door.

3. Trace the template onto protective film PN 51 77 7 404 141. Carefully cut out the traced design from the protective film.
4. Clean the door jamb area using Cleaner R2 PN 83 19 0 417 324 or isopropyl alcohol.
5. Remove the adhesive backing from the protective film and install in the area shown below on both front doors. The outer edge of the protective film should line up with the out edge of the door jamb exactly as shown.

Note: For clarity, the installation location is shown using the paper template. During repair, the clear protective film will be applied.
