SI B63 04 18  
Lights

## DAYTIME RUNNING LIGHT IS DIM OR DISCOLORED

This Service Information bulletin replaces SI B63 04 18 **dated August 2018**.

| G12 (7 Series) | G30 (5 series) | G32 (6 series GT) |

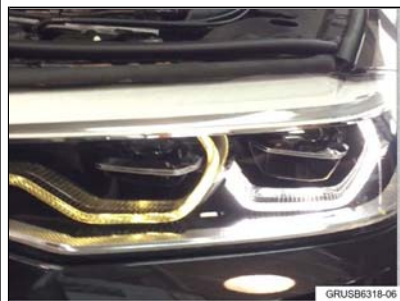
One or more of the LED daytime running lights are dim or discolored.

The connection between the LED module and light tube inside the headlight is damaged.

Inspect and replace the affected LED module. Replace the headlight only if internal damage is found to the light tube.

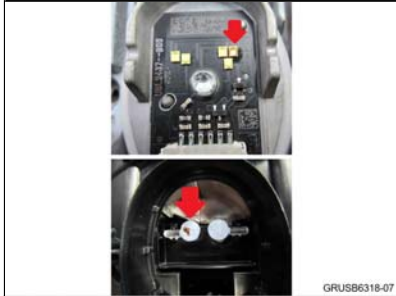
| | <ol style="list-style-type: none"> <li>2. Inspect the LED module for signs of discoloration as seen to the left. If discoloration is present, inspect the light tube of the headlight for signs of discoloration.</li> </ol> |

| | <ol style="list-style-type: none"> <li>3. Proceed as follows based on your inspection:<br/><br/> <b>Discoloration is present only on the LED module-</b> Replace the affected LED module only, following repair instructions REP 63 11 730 <b>“Replace the LED module(s) for left daytime driving lights (headlight LED, headlight LED adaptive light)”</b>.<br/> <b>Discoloration is present on the LED module AND the light tube:</b> Replace the complete headlight and the LED module, following repair instructions REP 63 12 141 <b>“Replace the left LED technology headlight”</b>. </li> </ol> |
