SI B63 07 18  
Lights

## TAILGATE LIGHT CRACKED

G01 (X3)
Produced from 8/1/2017-12/21/2018

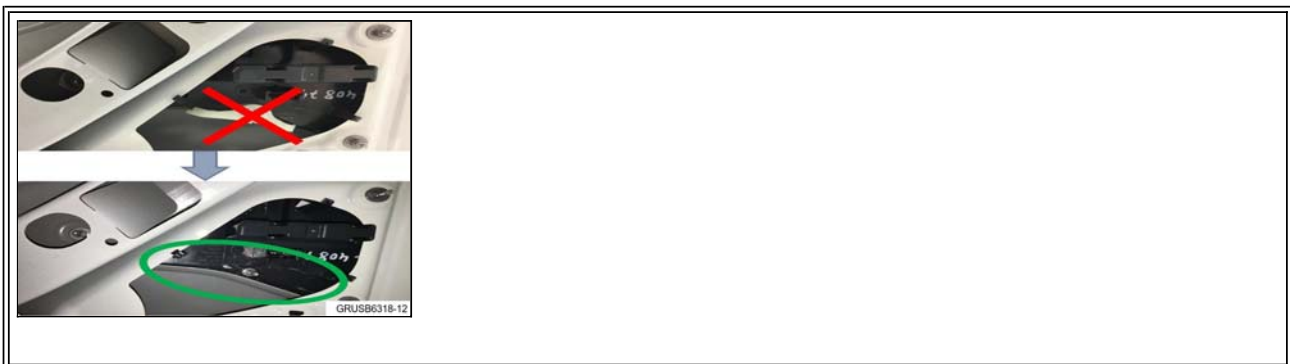
Cracks may be present in the rear lights mounted to the tailgate.

Stress caused by an additional mounting bracket.

During installation, do not re-install the lower mounting bracket shown below. This will reduce the stress that is causing the cracks to occur.

Note: When replacing only one light, remove the bracket from the other installed light as well. Ensure

both rear lights do not have a mounting bracket installed.
