TECH TIP

TT-19-001 DEF PUMP DIAGNOSTIC TECH TIP-
DTC P20E8

TECH TIP NO: TT-19-001

SUBJECT VEHICLES: 11MY-20MY Conventional Trucks equipped with a J08 engine or 12MY-20MY Cab-Over Engine (COE) equipped with a J05E engine.

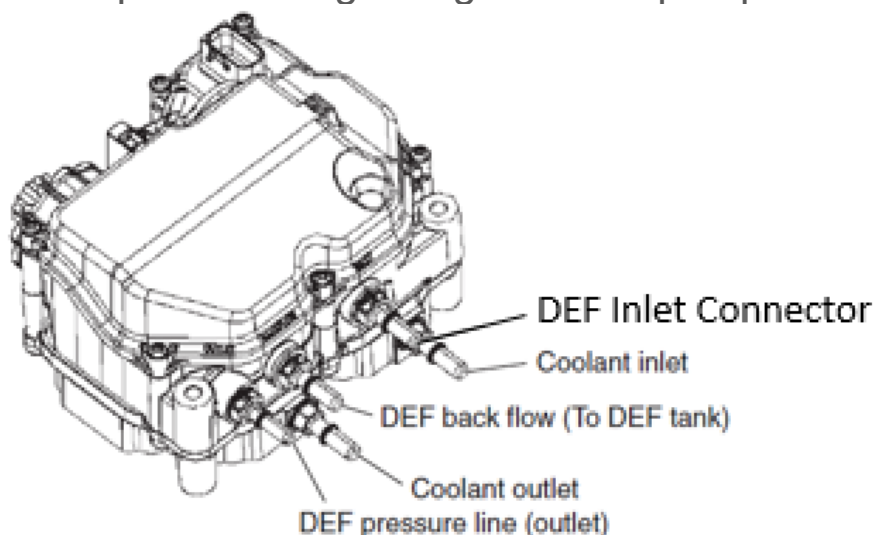
Subject vehicles may exhibit a MIL lamp on due to DTC (Diagnostic Trouble Code) P20E8 setting in the DCU (Dosing Control Unit). This DTC sets when low pressure of the DEF (Diesel Exhaust Fluid) pump is detected. Please review the diagnostic tips below regarding the DEF pump.

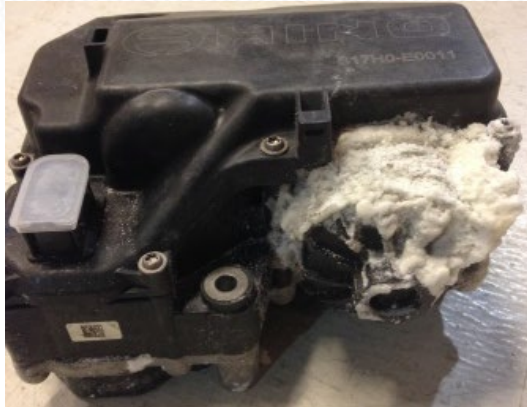
Leaks Around Filter Cap

If the DEF pump filter cap is improperly torqued, a leak around the filter cap, as depicted on the right, may occur. DO NOT replace the DEF pump for this condition. This is not a leak from the pump housing. If a leak occurs within the DEF pump, DEF will first come out of the electrical connector. The crystallized DEF can be scraped off and/or dissolved with water. Replace the DEF filter (Part No. S17K0E0011, which includes a new seal) to address this condition.
