SI B11 11 18
Engine

SERVICE ACTION: N63R ENGINE – CHECK AND REPLACE VANOS ACTUATORS, OIL FEED LINES, CHARGE AIR COOLERS AND THE MAP THERMOSTAT ELECTRICAL CONNECTOR

This Service Information bulletin replaces SI B11 11 18 **dated October 2018**

This Service Action involves G12 vehicles produced from May 2015 to July 2016.

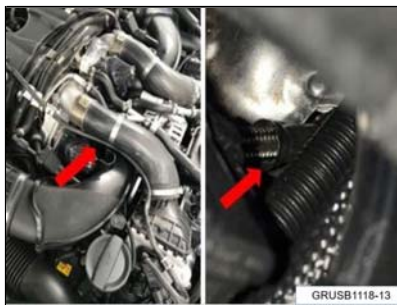
Oil feed line construction overview:

1. (Stainless steel flexible section. This is the new design and should not be replaced.

2. Black rubber flexible section. This line should be replaced.

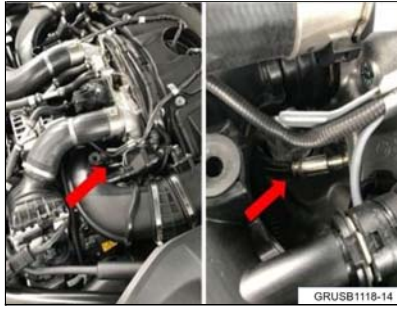
2. Check the exhaust turbocharger oil feed line on bank 1.

If the flexible section of the feed line is made of braided stainless steel (see arrows) then take no further action. **Do not replace the line.**

If the flexible section is black rubber then the oil feed line will need to be replaced.

UPDATE! Refer to Repair Instruction 11 42 200 "Remove and install / renew the oil feed line for the exhaust turbocharger N63O2"
Do not remove the turbochargers!

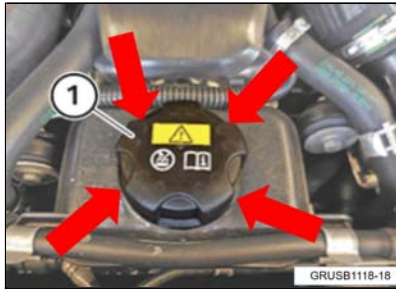
1. Locate and inspect the low temperature cooling system cap (1) for traces of overflowing.

2. Do not remove the cap, if there are traces of wet or dried coolant around the cap surface then it is overflowing.

If found overflowing, replace both charge air intercoolers.

If not leaking, do not replace any parts and do not drain the cooling system.

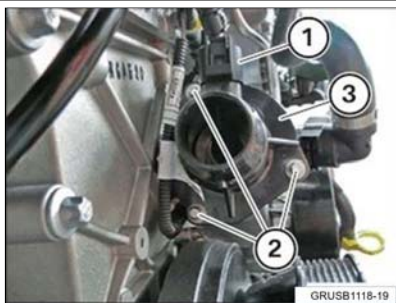
1. Locate the Map Thermostat Electrical Connector (1).

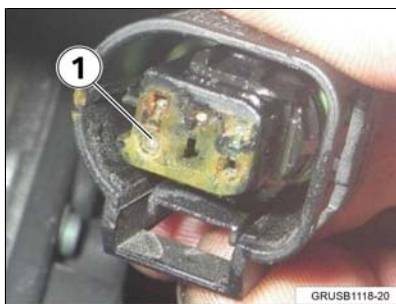
2. Remove the connector and check the pins in the connector for traces of water or corrosion.

Example: This connector is already corroded.

If the pins in the connector are corroded, the engine wiring harness and the characteristic map thermostat need to be replaced.

Refer to the following Repair Instructions:

12 51 300 "Removing and installing/replacing the wiring harness section of engine ignition control for cylinders 1-4".

11 53 000 "Removing and installing/replacing the coolant

thermostat”.
