SI B11 15 16
Engine

January 2019
Technical Service

B58 ENGINE: OIL LEAK FROM TURBOCHARGER

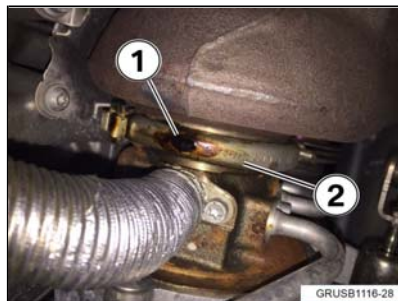
Engine oil (1) can be seen leaking from the bottom of the turbocharger near the band clamp (2).

The turbocharger band clamp is loose.

Tighten the turbocharger band clamp.
