SI B11 18 18
Engine

SERVICE ACTION: ALPINA B7 WITH N63R ENGINE – CHECK AND REPLACE OIL FEED LINES AND THE MAP THERMOSTAT ELECTRICAL CONNECTOR

G12 (ALPINA B7 Sedan)

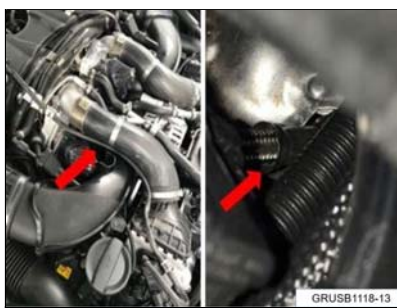
2. Check the exhaust turbocharger oil feed line on bank 1.

If the flexible section of the feed line is made of braided stainless steel (see arrows) then take no further action. **Do not replace the line.**

If the flexible section is black rubber then the oil feed line will need to be replaced.

Refer to Repair Instruction 11 42 200 "Remove and install / renew the oil feed line for the exhaust turbocharger N63O2"
Do not remove the turbochargers!

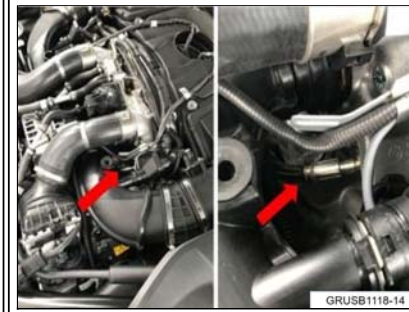
3. Check the exhaust turbocharger oil feed line on bank 2.

If the flexible section of the feed line is made of braided stainless steel (see arrows) then take no further action. **Do not replace the line.**

If the flexible section is black rubber then the oil feed line will need to be replaced.

Refer to Repair Instruction 11 42 200 "Remove and install /

**renew the oil feed line for the exhaust turbocharger N63O2”
Do not remove the turbochargers!**

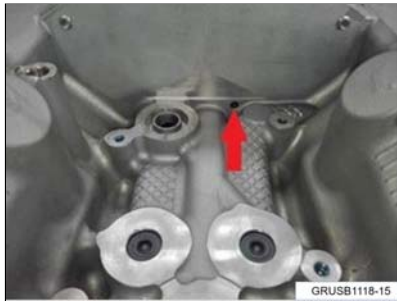
4. Only if the oil feed lines were actively leaking oil.

Check the engine block (V-space) for engine oil residue and clean as needed.

If there is leakage, the exhaust system, both exhaust turbochargers, the lower heat shield, the complete exhaust manifold and the oil-to-coolant heat exchanger needs to be removed to clean this area.

Wipe dry with a shop towel and rinse the residual oil with cleaner via the drain hole and flush it out (see arrow).

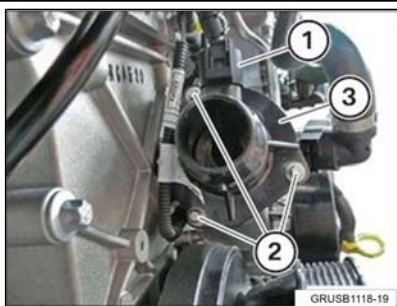
1. Locate the Map Thermostat Electrical Connector (1).

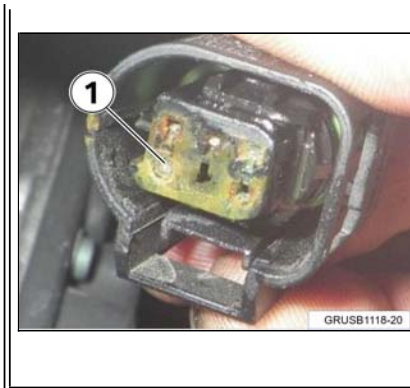
Example: This connector is already corroded.

If the pins in the connector are corroded, the engine wiring harness and the characteristic map thermostat need to be replaced.

12 51 300 "Removing and installing/replacing the wiring harness section of engine ignition control for cylinders 1-4".

11 53 000 "Removing and installing/replacing the coolant thermostat".
