## SERVICE ACTION: MECHANICAL STEERING COLUMN

This Service Information bulletin replaces SI B32 01 19 **dated January 2019**

F39 (X2)	F48 (X1)
----------	----------

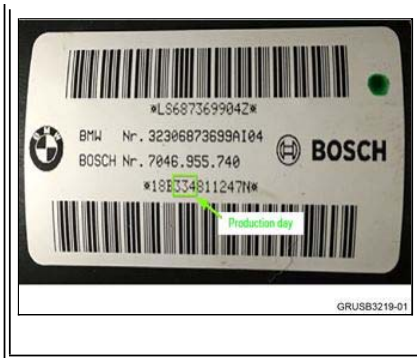
2. Locate the manufacturing date as indicated in the photo to the left.

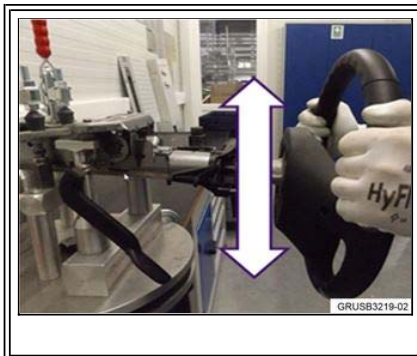
3. Was the steering column manufactured on the 334th day?
