SERVICE ACTION: REWORK THE STEERING GEAR

This Service Information bulletin replaces SI B32 08 18 dated October 2018

MODEL

STEERING GEAR POWER SUPPLY ATTACHMENT REWORK

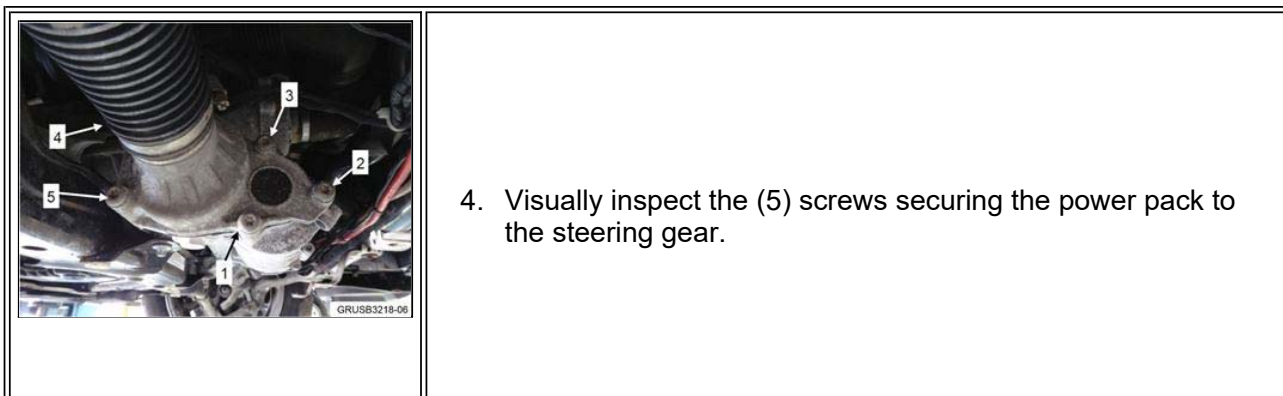
Screws attaching the power pack to the steering gear may be broken. Broken screws result in noises during steering motions and variable steering assistance.

Are any of the screws, in the (5) indicated locations, missing or been obviously sheared off?

YES – Go to next step.

NO – Perform the attached Steering Gear Power Supply Attachment Rework procedure.

5. Reconnect the battery.
6. Connect the vehicle to ISTA/D and perform a vehicle test.
7. Following repair instructions **REP 32 13 572**, replace the steering gear.
8. Following repair instructions **REP 32 00 155**, perform a wheel alignment.
9. Work through the measures plan and program the vehicle using ISTA 4.12.30 or higher.

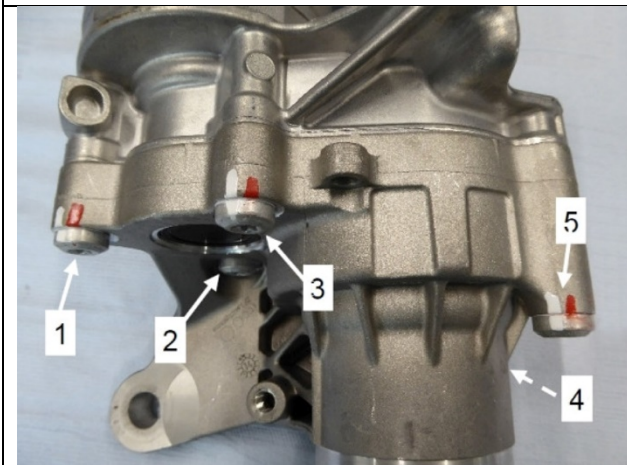
**Warning: Do not loosen more than one screw at a time or damage to the steering system may occur!**

4. Replace the five indicated screws, **one at a time**, using the following procedure.

- A. Remove screw 1.
- B. Discard the screw.
- C. Install a new screw using an electronic torque wrench.

Torque: 5 Nm (+/- 0.5 Nm) +90° angle of rotation (+0° / -20°).

- D. Mark the installed screw with a white paint pen (similar to illustration).
- E. Repeat the procedure for remaining screws 2, 3, 4, and 5, verifying replacement status on the basis of the paint marks.
