SI B65 04 19  
Drivers Assistance, Remote Control Systems

January 2019  
Technical Service

## SPANISH OR FRENCH TEXT IS DISPLAYED WITHOUT SPACES

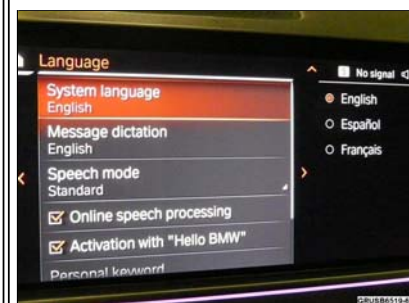
In the selectable Spanish or French languages, text shown in the Central Information Display may be incorrectly displayed. There are no spaces between words.

Formatting problems in the in MGU (Media Graphics Unit).

Program the vehicle with ISTA 4.15.1x or higher to Integration level (I-level) S18A-18-11-545 or a more recent version. ISTA 4.15.1 became available early December 2018.
