FM RADIO STATIC HEARD BETWEEN 88 TO 97 MHZ

G05 (X5 Sports Activity Vehicle)	G12 (7 Series Sedan)	G15 (8 Series Coupe)	G30 (5 Series Sedan)
G32 (640i Gran Turismo)	I12 (i8 Coupe)

Vehicles produced from July 1, 2018 to November 5, 2018

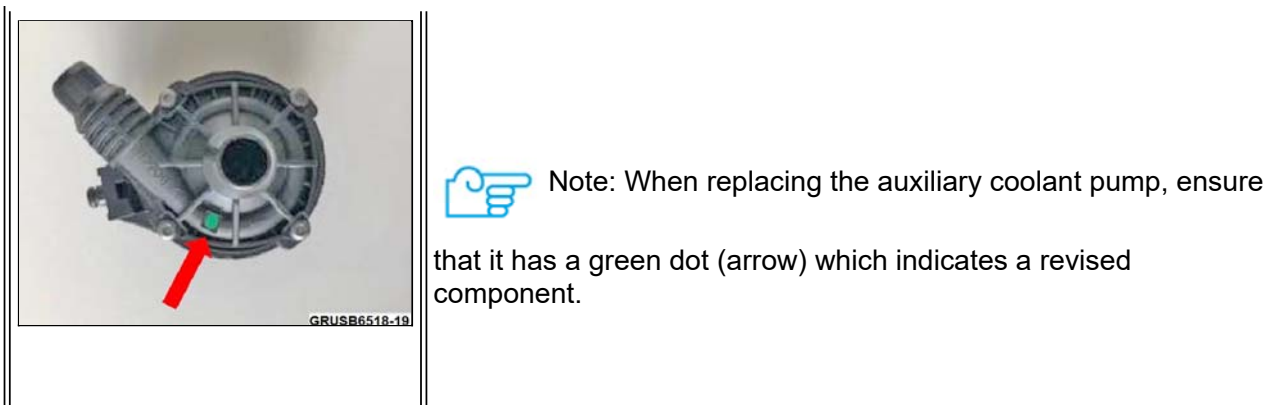
If it is one of the part numbers below, the auxiliary coolant pump must be replaced:

- 11 51 8 679 885
- 64 11 6 834 923
- 11 51 8 671 654

3. Follow Repair Instructions REP 64 11 262 "Removing and installing/replacing the coolant pump".
4. After installation of the new auxiliary coolant pump, bleed the cooling system.
 - **For all models except I12:** Follow SI [B17 01 10](#) "Proper evacuation and/or filling of cooling system after repairs"
 - **For I12 only:** Follow SI [B17 02 18](#) "Proper coolant bleeding procedure"
5. Verify the absence of radio static interference on the FM band after moving the vehicle outdoors.
