AUDIO SYSTEM AMPLIFIER(S) INOPERATIVE

G12 (7 series)	
----------------	--

Water leak in luggage compartment repair attachment

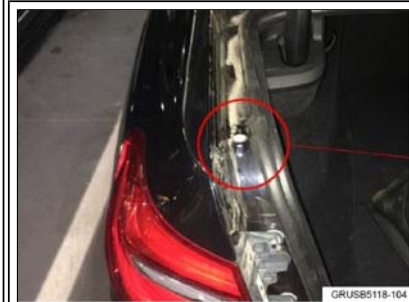
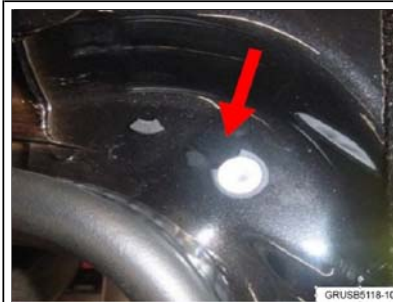
The foam seals of the trunk water channel clips may be missing or damaged, allowing water to damage the AMP or ASD.

Inspect and replace any water channel clip with missing or damaged foam seals. Replace the AMP and/or the ASD, if damaged by water ingress. Check wiring harness connectors/pins for corrosion

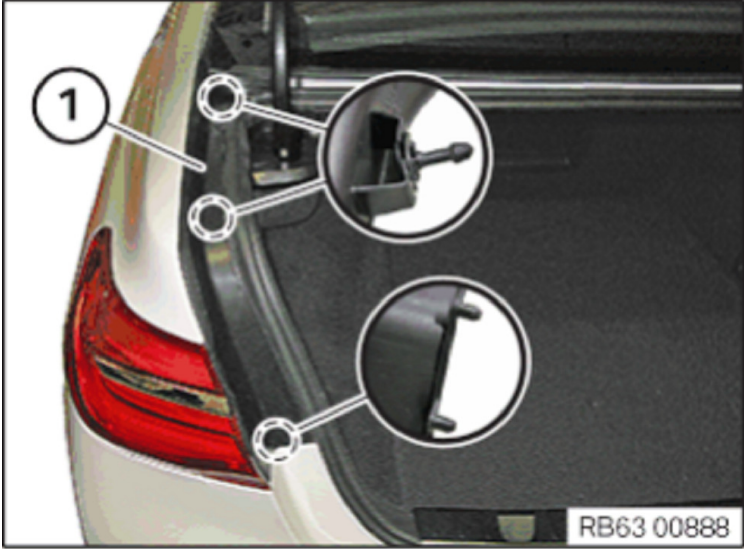
<p>1. Remove left side cover inside trunk and inspect Amplifier(s) for water infiltration</p>
	<p>2. Was corrosion or water ingress of the trunk found?</p> <p>Yes: Proceed to step 3 to remove both water channels.</p> <p>No: Continue diagnostics for audio system</p>

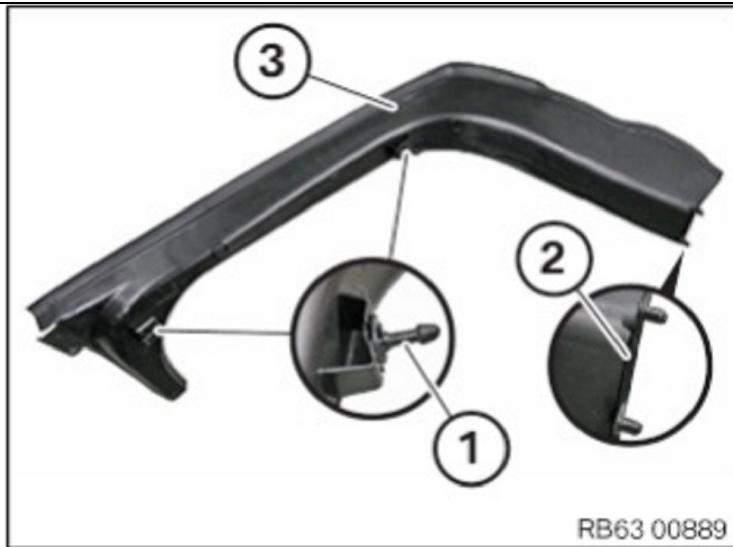
4. With both water channels removed, inspect the foam sealing rings of all 4 retaining clips for damage.

5. If any retaining clip seals are damaged or missing, replace the clips.

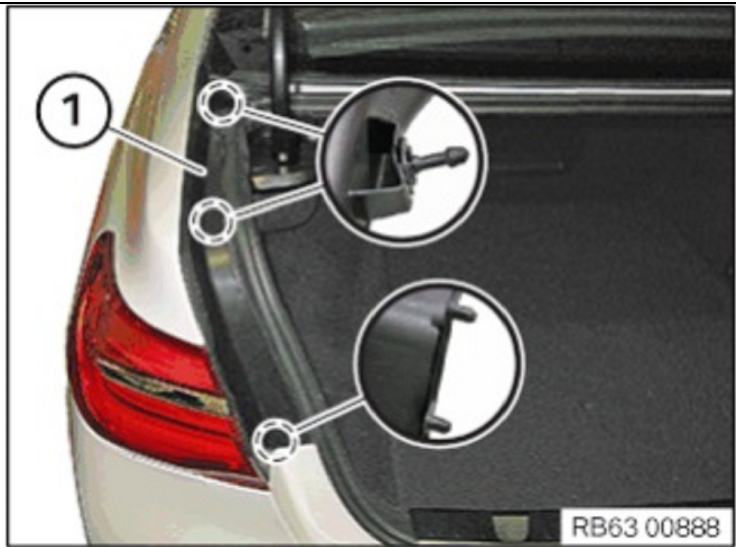
6. Check the clips (1) and guides (2) on the water channels for damage. If water channel clips are damaged, the water channel must be replaced.
