FAULT CODE 804417 CAUSED BY THE REMOTE KEY

G01 (X3 Sports Activity Vehicle)	G02 (X4 Sports Activity Coupe)	G05 (X5 Sports Activity Vehicle)	G07 (X7 Sports Activity Vehicle)
G12 (7 Series Sedan)	G14 (8 Series Convertible)	G15 (8 Series Coupe)	G20 (3 Series Sedan)
G29 (Z4 Roadster)	G30 (5 Series Sedan)	G32 (6 Series Gran Turismo)

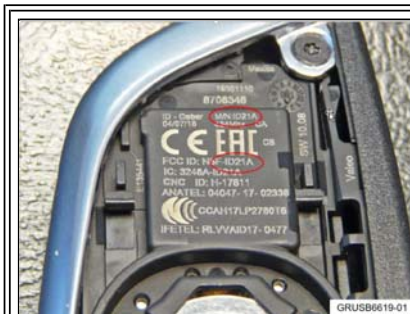
MEMS sensor in the remote key transmitter version 2.1. Remote keys can be differentiated between version 2.1 and the earlier version 2 by removing the back cover. Carefully check the ID printed in various places (circled). G05 basic remote key shown; other models similar.

- ID21= version 2.1 (contains motion sensor)
- ID2= earlier version (no motion sensor)

The fault code can sometimes be created erroneously. In the case of a fault memory entry, it is not evident whether the fault is erroneous or actual.

Follow the procedure below to determine if the MEMS contains an actual fault, or if is simply an erroneous fault.

- If the vehicle unlocked before the key was moved at Step 9, repeat the test.
- If the vehicle can still be opened before the key was moved (at Step 9), it is likely that the MEMS in the key is faulty. Replace the remote key.
 - o Refer to Repair Instructions 66 12... "Teach in radio remote control/radio remote control with display (BMW display key)"
