SI M62 01 19
Instruments

CENTRAL INSTRUMENT PANEL LED SURROUND RING DOES NOT ILLUMINATE WHEN IGNITION IS TURNED ON

F54 (MINI Clubman)	F55 (MINI Hardtop 4 Door)	F56 (MINI Hardtop 2 Door)	F57 (MINI Convertible)
F60 (MINI Countryman)

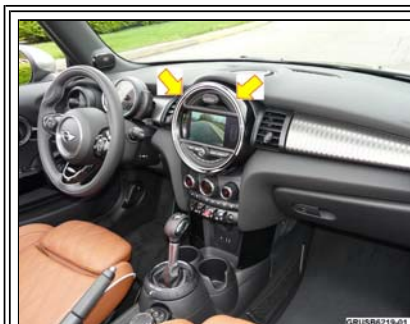
The central instrument's outer perimeter LED ring (arrows) does not illuminate when switching on the ignition, or with the engine start-stop button. It only illuminates after direct actuation of a component (e.g., setting the temperature, radio volume, etc.). F57 shown; other models similar.

Software error in the Automotive Pixel Link driver (APIX driver).

- If the I-level is older (lower) than 19-07-5xx:
 - o Program/encode the vehicle to I-level 19-07-5xx or higher.
 - o This will be supported by ISTA 4.18.x, **estimated available in early July, 2019.**
