SI M65 03 18  
Audio, Navigation, Information, Safety Systems

January 2019  
Technical Service

## FM RADIO STATIC HEARD BETWEEN 88 TO 97 MHZ

| F60 (MINI Countryman) |

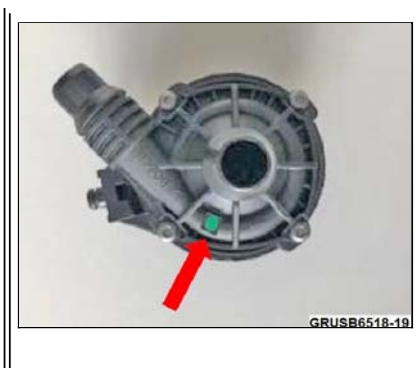
Note: When replacing the auxiliary coolant pump, ensure that it has a green dot (arrow) which indicates a revised component.

3. Follow Repair Instructions REP 11 51 000 "Removing and installing/replacing the coolant pump".
4. After installation of the new auxiliary coolant pump, bleed the cooling system.
5. Verify the absence of radio static interference on the FM band after moving the vehicle outdoors.
